Final Report

SUDS in Scotland – The Monitoring Programme
of the Scottish Universities SUDS Monitoring Group

March 2004

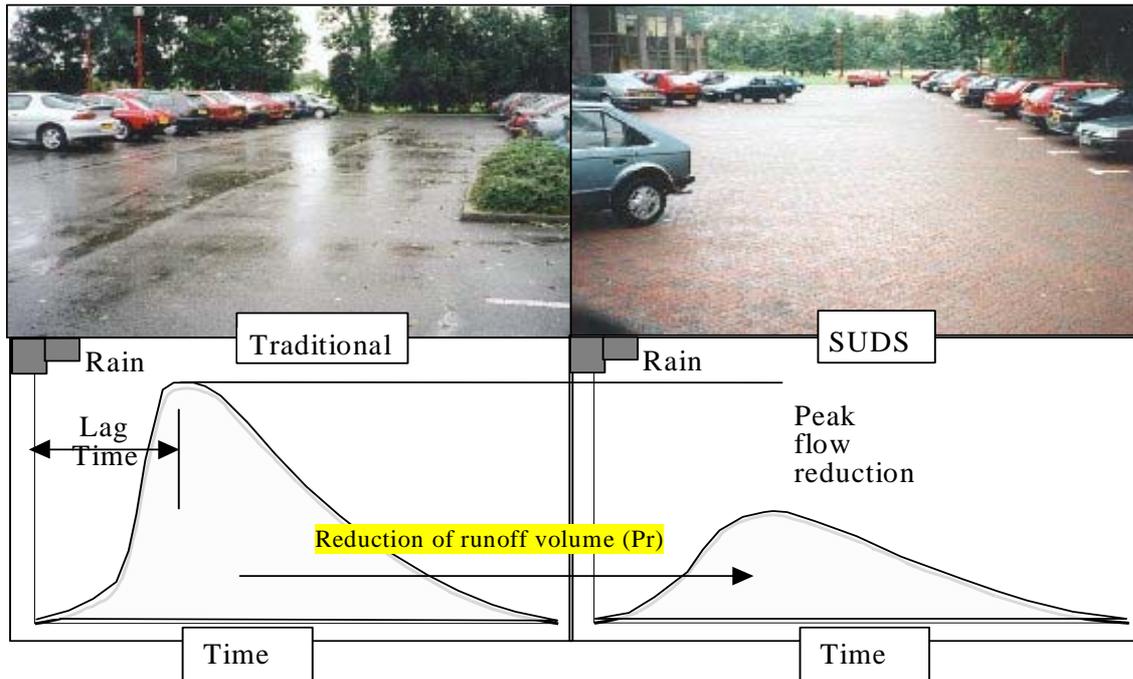
Figure 3.1 Interpretation of Key hydrological Parameters

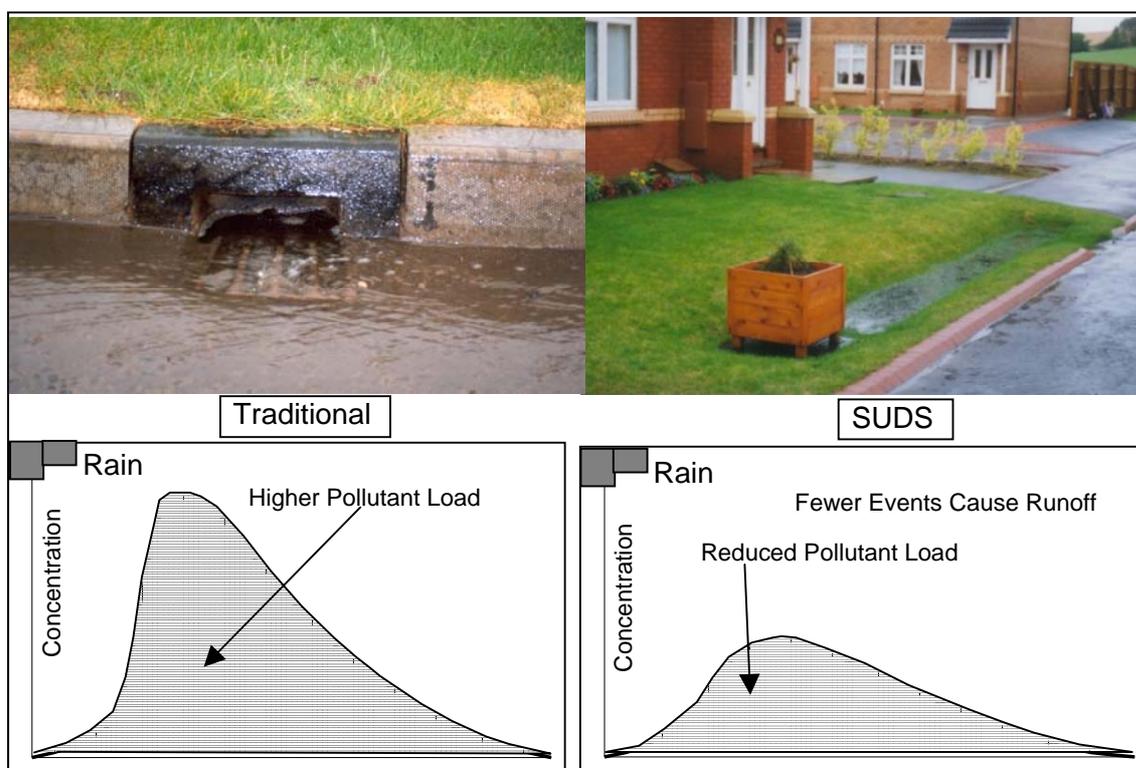
Figure 3.2 Interpretation of Key Water Quality Parameters

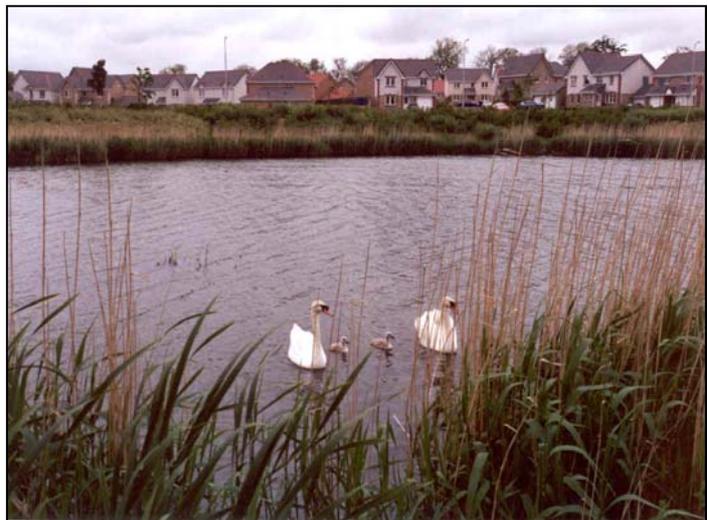
Linburn pond, This is one of the regional SUDS ponds in the Dunfermline DEX development. The vegetation was planted in March 1998 was expected to suffer from vandalism but this has been much less than was anticipated. Perennial shrubs and reeds have flourished by this pond and they now present a formidable barrier round most of its perimeter in addition to the low metal fence. The appearance of Linburn Pond and the detention basin across the road is very pleasant and has a feeling of being a wild place within the city which is unpolluted and supports wildlife.

Figure 4.1 Linburn Pond 2001

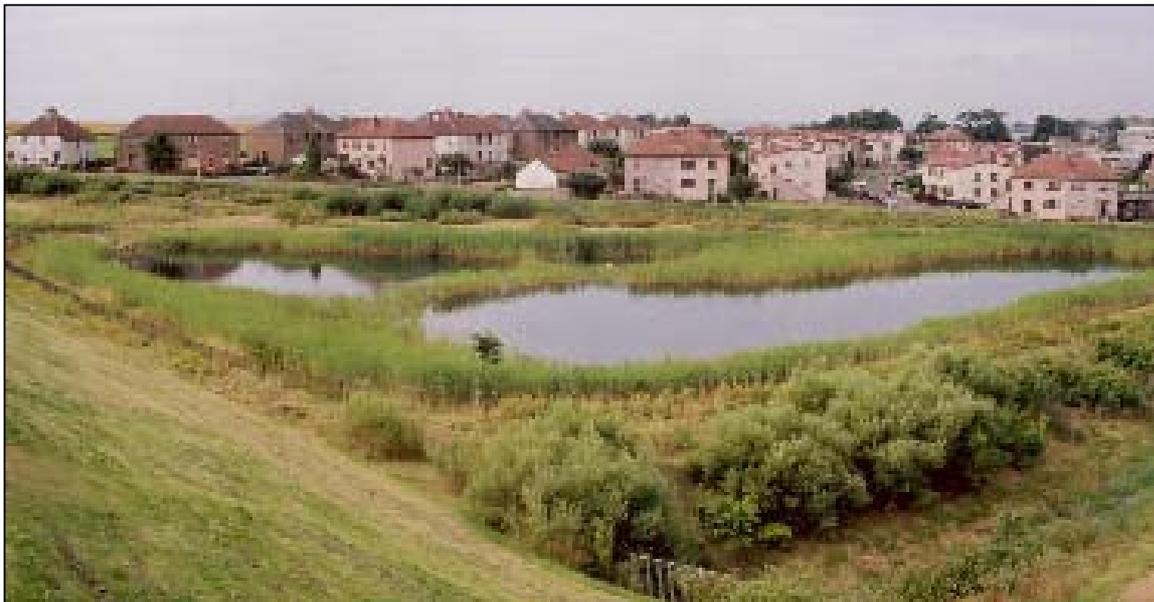
Cement was spilled into Hallbeath pond in Sept 1999, covering the sediment in the inlet section for a period, but none escaped to the watercourse and no trace is now visible. Although the area has suffered from vandalism, abundant wildlife may now be observed, and swans have been resident every summer since 1999. Algal mats have routinely formed on Halbeath Pond although there appears to be very little nutrient sources on the contributing catchment area. Sediment continues to accumulate close to the inlet, but this is more or less what would be expected, and measurements show that it amounts to no more than 10% of the total water volume.

Figure 4.2 Hallbeath Pond 2001

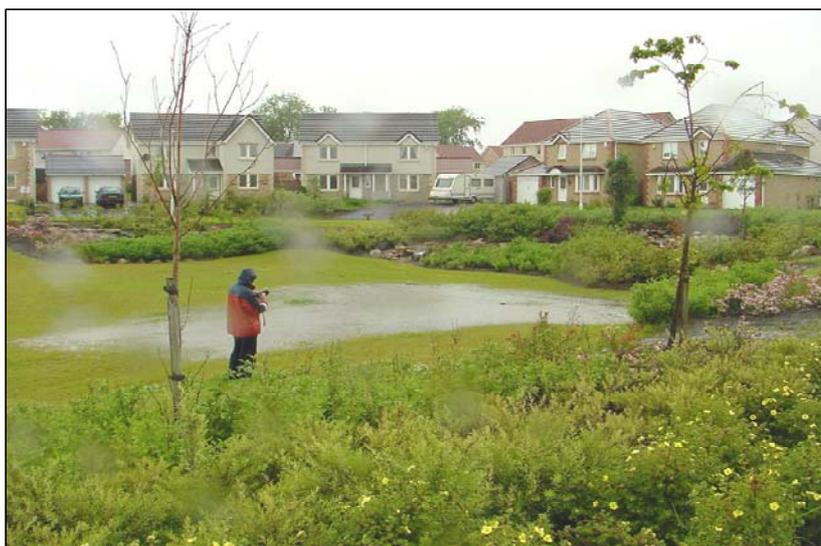
In the five years of operation, no pollution incidents have been noticed and the surface is clearly safe for children playing. However, construction activity on the adjacent housing development has caused a bank of sediment to form at the inlet and this will need to be removed at some time. The high quality amenity provided and the basin's prominent location means that any malfunctioning is likely to be noticed early and action taken – due to community pressure as much as actual malfunction.

Figure 4.10 Linburn Detention Basin during a July thunderstorm

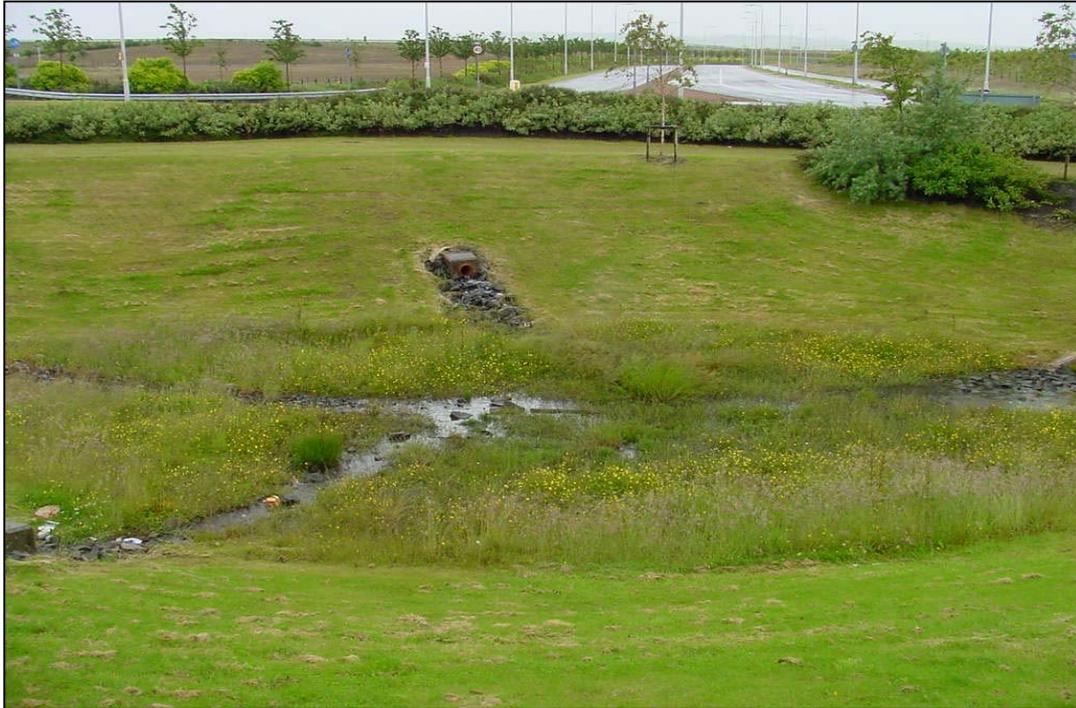
This basin has been constructed in a roundabout in the DEX development, and required much inter-agency negotiation to resolve safety and ownership issues. The basin serves access roads which link the development to a motorway.

Figure 4-11 (a) Basin B in summer

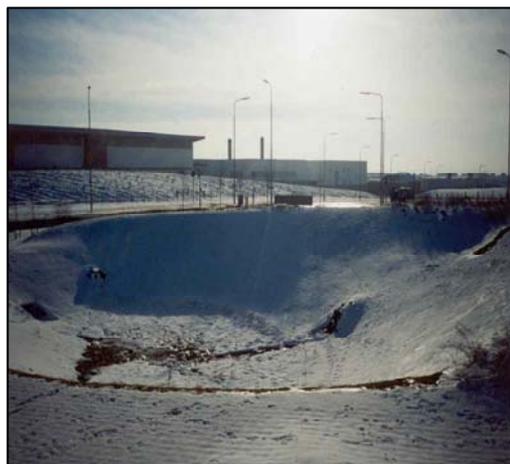
The base of basin B is frequently marshy, but ponding has only been observed on one occasion. A moderate amount of sediment had accumulated at the outlet and this has continued even though construction has ceased. In 2000 it was reported that sediment accumulation was not a problem at any of the inlets, but had accumulated at the outlet, and grass and sediment partially blocked the outlet throughout the year. Oil was observed on several visits, but never in significant quantities. Tar was discharging from the east inlet on one occasion and accumulated on the rocks below the device. Even during heavy rain, the amount of water in the basin has never been more than a large puddle. The side slopes are regularly mowed, while the base is left to grow uncut.

Figure 4-11 (b) Basin B in winter

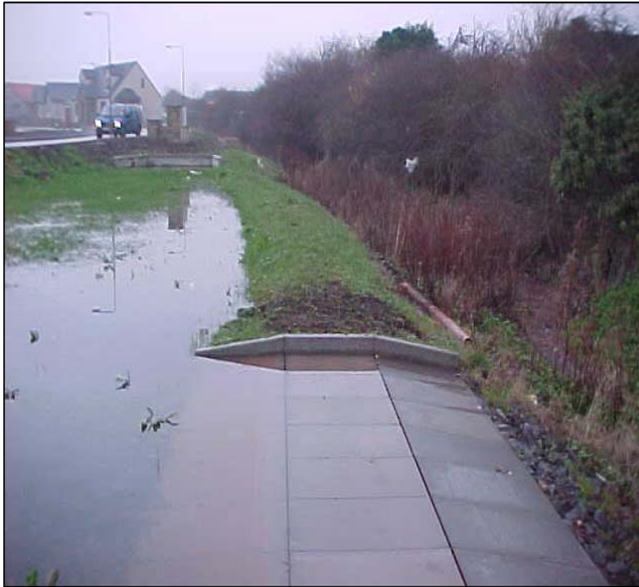
Figure 4.14 illustrates the need for training of construction supervisors and contractors together with better detailing. The basin is in an excellent location at the entry to a new development on the edge of a rural village and has an open appearance. The detention basin receives inflow from one inlet and, once the basin is full of water, it will spill over the weir in the foreground. Unfortunately, no draindown arrangements were made and the basin has permanent water, killing vegetation and having an unsightly muddy appearance. Appropriate draindown details might have been permeable material in the bank to the right of the photograph, permitting slow drain down, or small diameter pipes. Remediation works were implemented after this photograph was taken.

Figure 4.14 Detention Basin, Balmullo

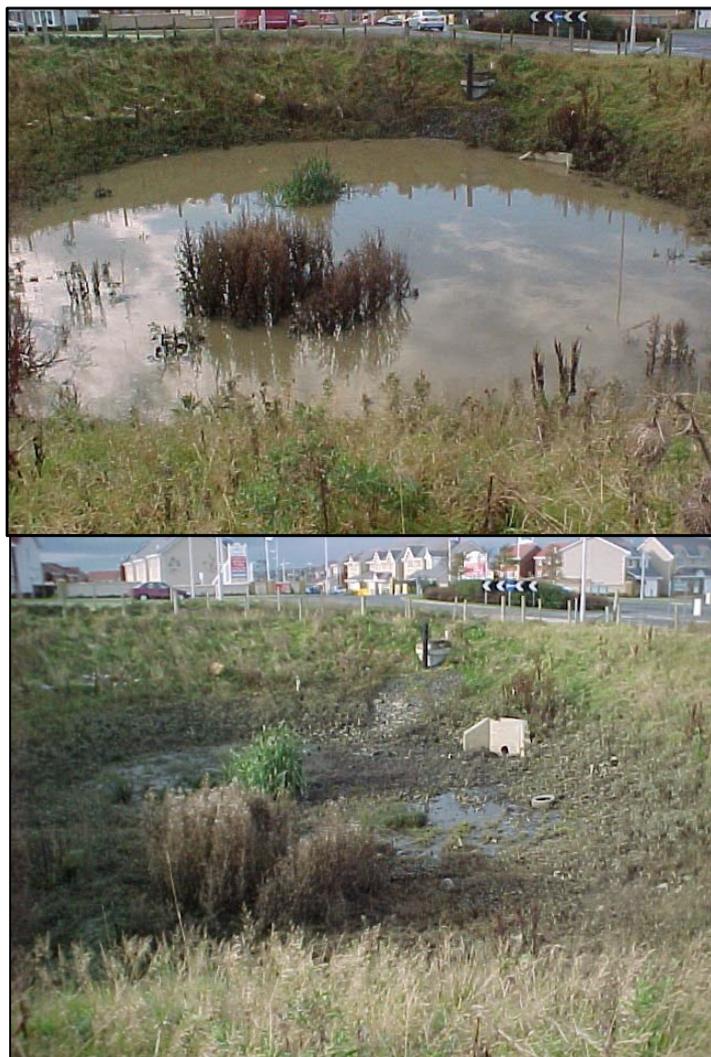
Figure 4.15 illustrates a detention basin serving a superstore during and after prolonged rainfall. Runoff from the store roof enters the pond uncontrolled, while the car parking areas drain through Formpave blocks. The basin (designed as extended detention) has an unkempt appearance since little or no landscaping was carried out. It is also relatively deep and small and to many, does not have a satisfactory appearance. However, native species are colonising the base and, from all appearances, the basin has a positive effect on water quality.

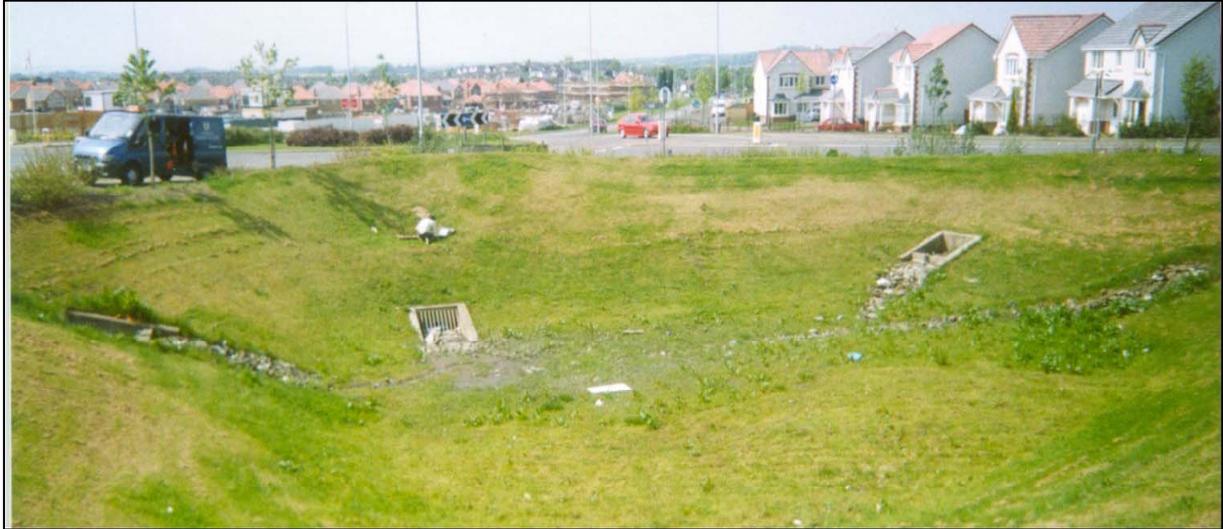
This basin was completed 1998 and suffered from a blockage of the outlet. This was the only example of a serious blockage encountered during four years of monitoring of basins and notes from routine visits are included here to illustrate some of the issues involved.

Figure 4.16 Detention Basin G

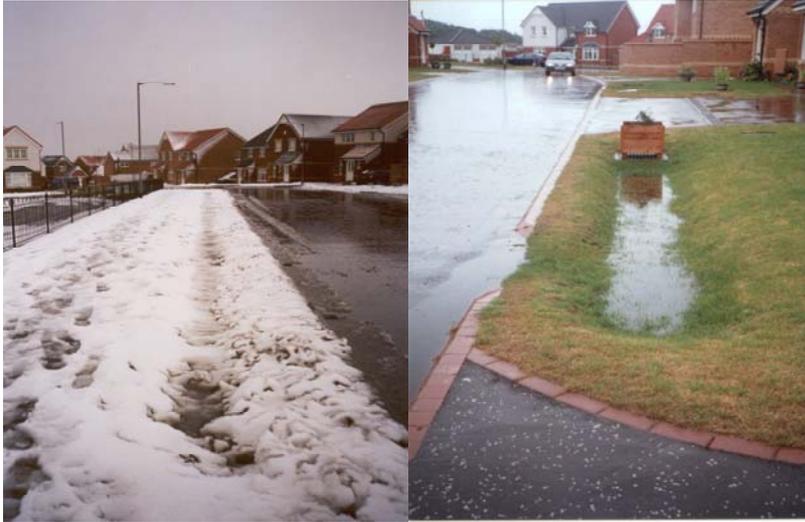
Roadside detention basins produce an undulating appearance to the road margins and are relatively easily maintained. Surveys have shown that there is little resistance from residents even though they are periodically full of water. Figure 4.19 shows two further examples.

Figure 4.19 Roadside Detention under different weather conditions

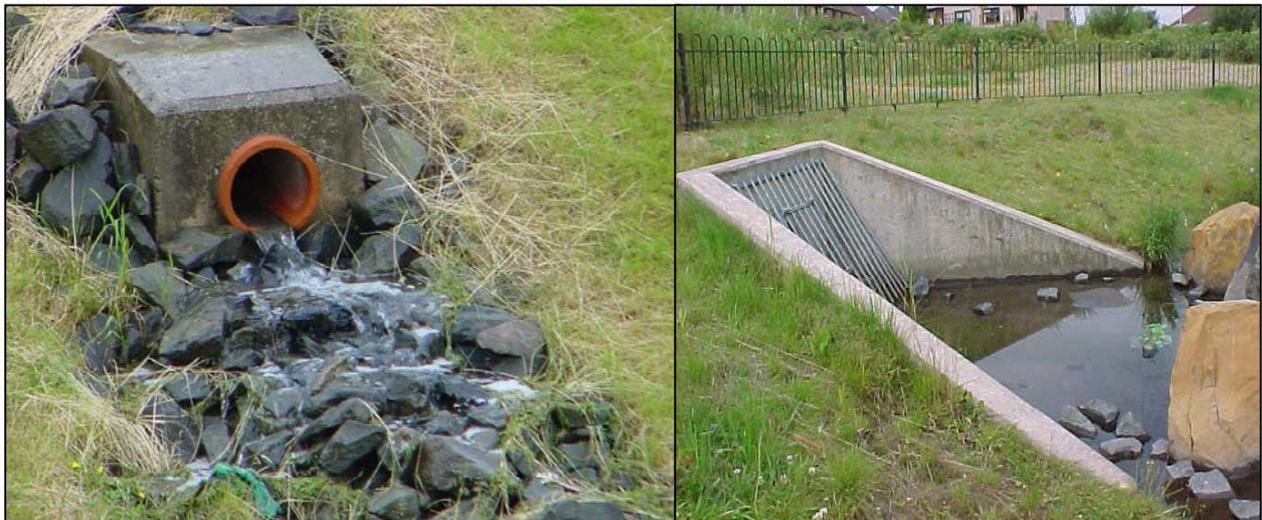
A wide variety of inlets are used and examples each of small and a large inlets are included in figure 5.1. In general it was clear that the designers were aware of good practice and the inlets were appropriate for the locations, where major flows and velocities were expected, inlet structures tended to be constructed from concrete. In contrast, most small inlets where erosion control was not a significant issue, were formed by pipes protruding from the sloping bank. Erosion around inlets was rarely noted indicating generally appropriate engineering detailing, examples of deficiency generally being rectified at the end of the construction maintenance period. Overall, there was no evidence of recurrent problems arising from poor inlet detailing.

Figure 5.1 Typical Pond Inlets (equally applicable inlets are shown in figure 6.1)

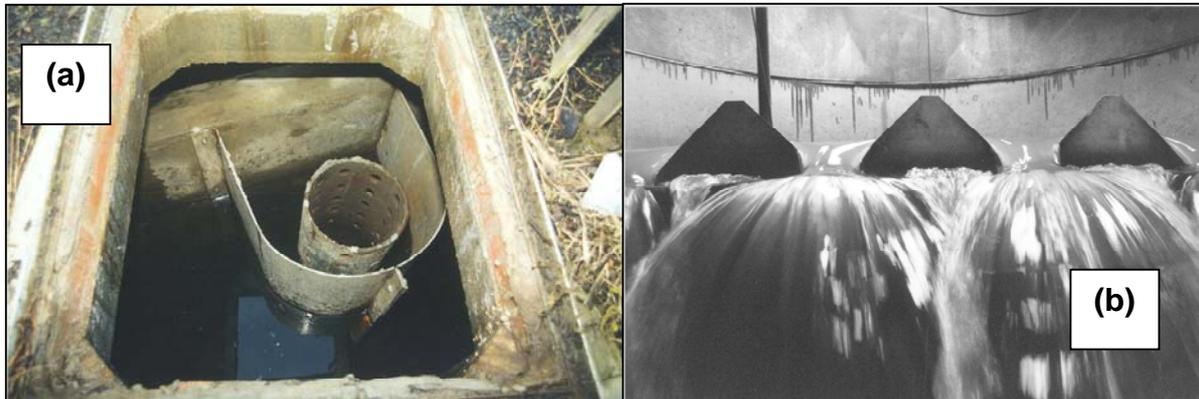
Figure 5.2 Underground pond outlets – (a) slotted standpipe pipe; (b) Multiple 90⁰ Vee notches

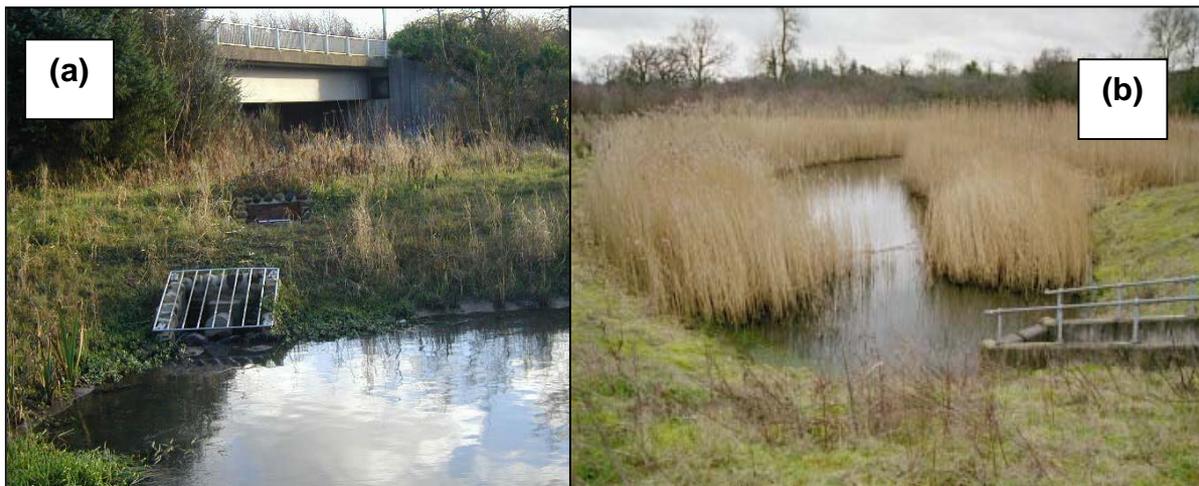
Figure 5.3 Exposed pond outlets using Hydrobrake (a) and Narrow vertical slot (b)

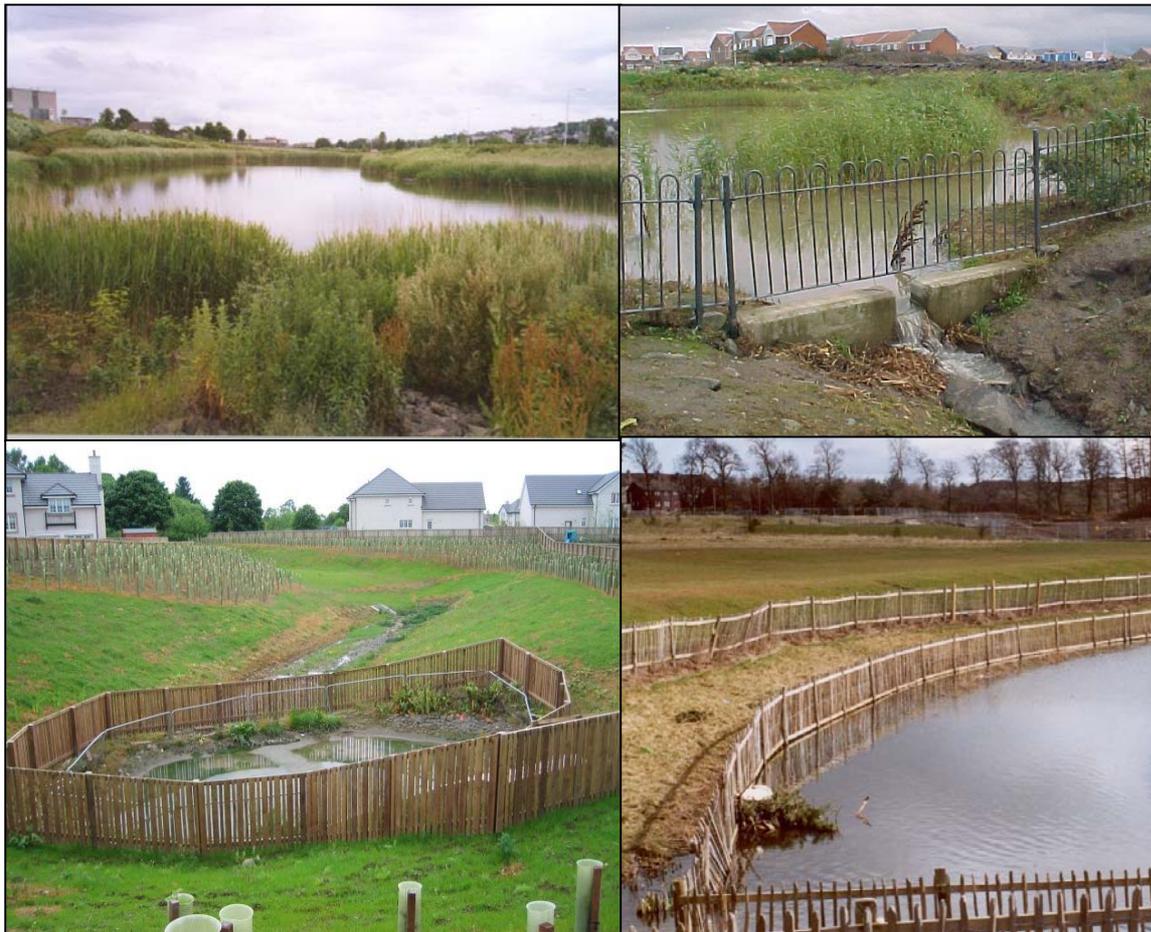
Figure 5.4 Planted and erected barriers at three ponds and one detention basin (bottom left).

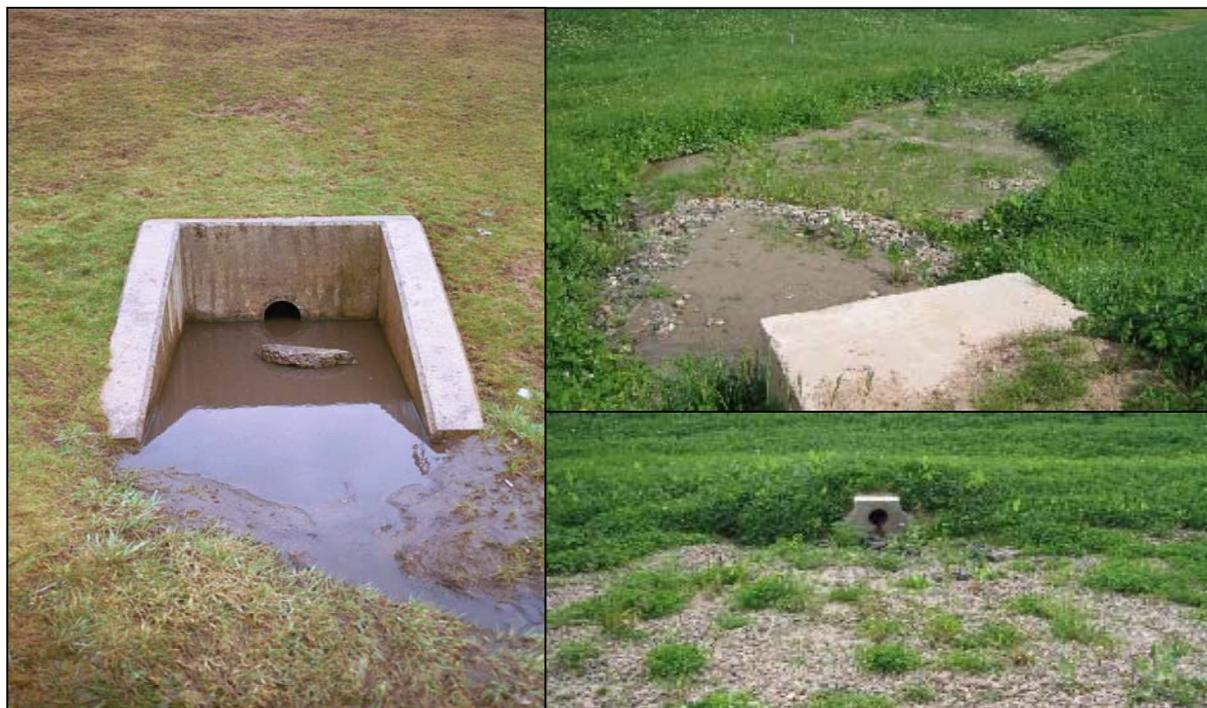
Figure 6.1 Detention Basin Inlets

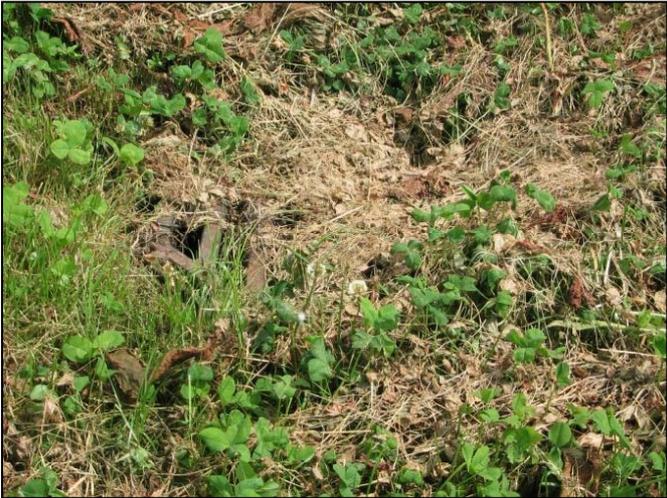
The fundamental principles of outlets are well known to design engineers. Unfortunately, several examples of blockage or potential blockage have been found and an example is shown in figure 6.2. It is apparent that insufficient thought is often given to access for blockage clearing. For example, manholes become surcharged making it impossible to clear a blockage. A further example is given in summary sheet 9.

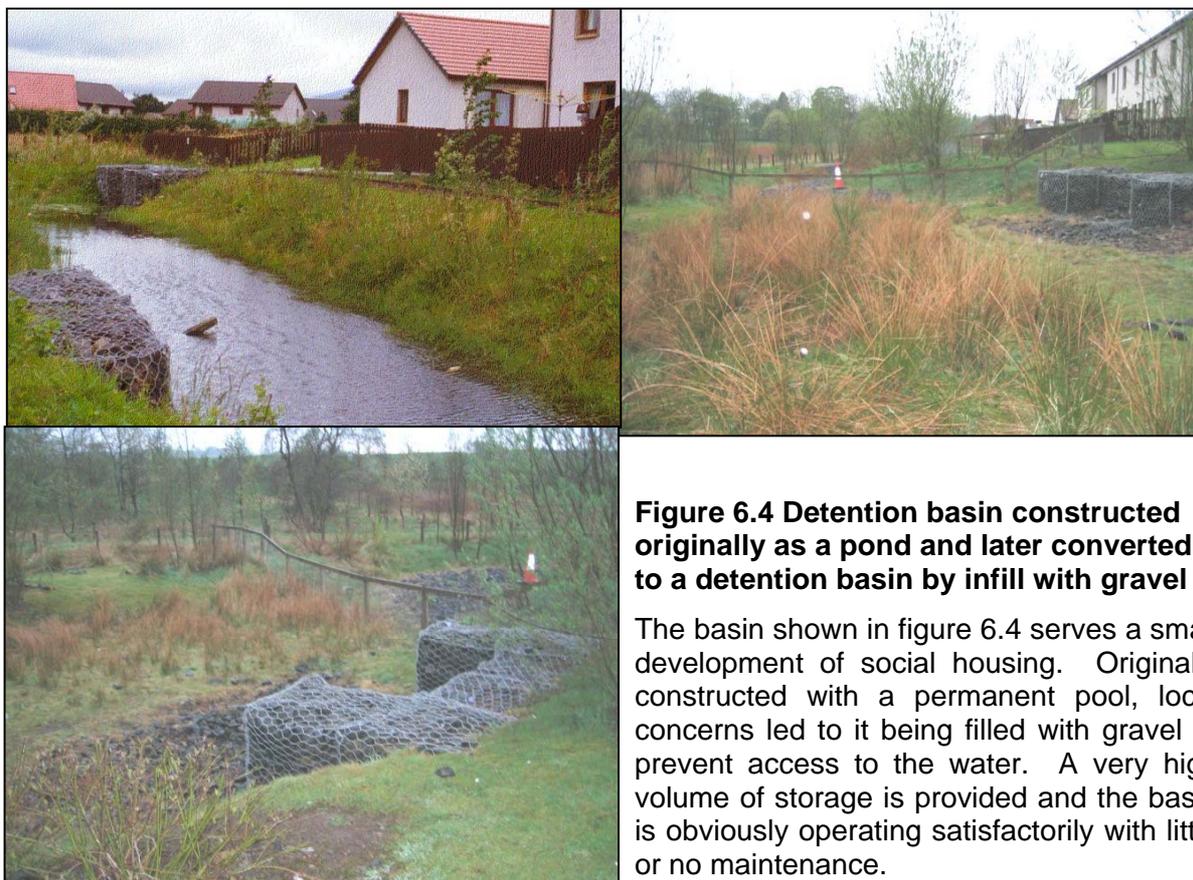
Figure 6.4 Detention basin constructed originally as a pond and later converted to a detention basin by infill with gravel

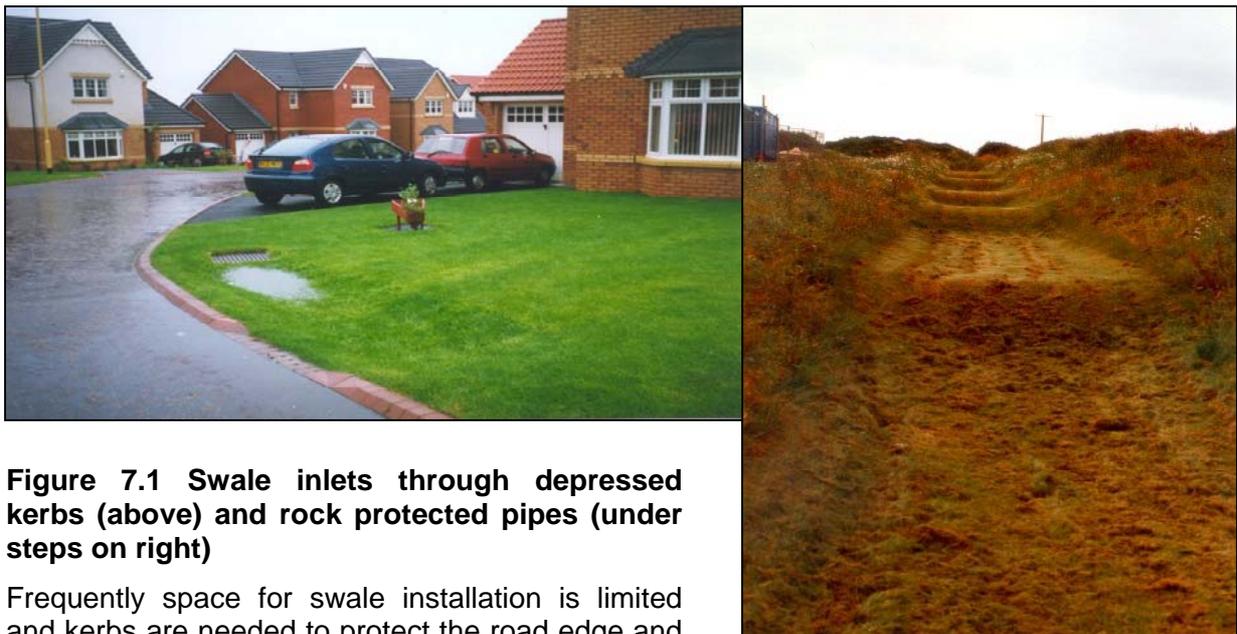
Figure 7.1 Swale inlets through depressed kerbs (above) and rock protected pipes (under steps on right)

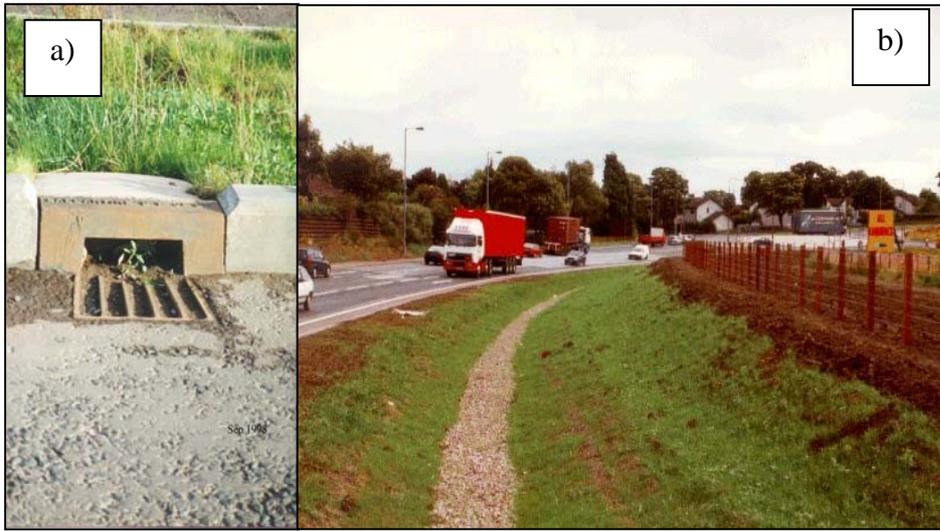
Figure 7.2 Swale inlets a) through Clearway units (no longer used due to frequent blockage); b) lateral inflow.

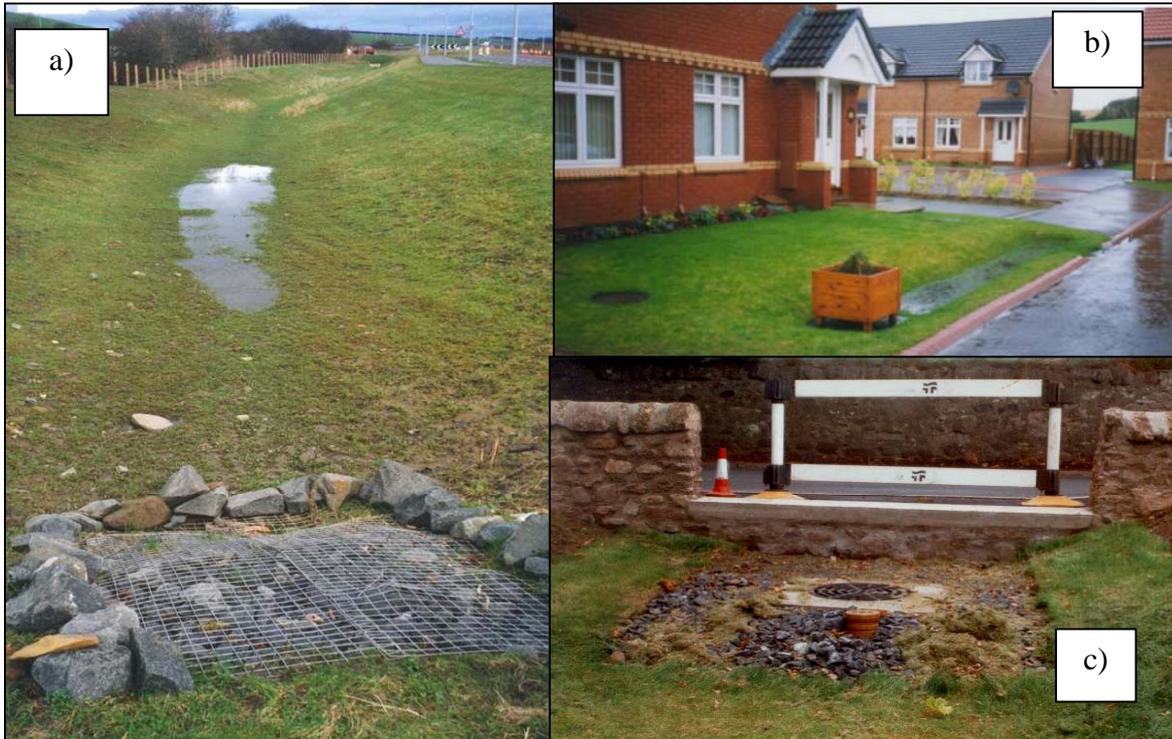
Figure 7.3 Swale Outlet arrangements a) small diameter pipe under rock protection in foreground; b) Planter placed to conceal grating on raised outlet to small roadside swale; c) Raised outlet at lower end of stepped swale illustrated in figure 7.1.

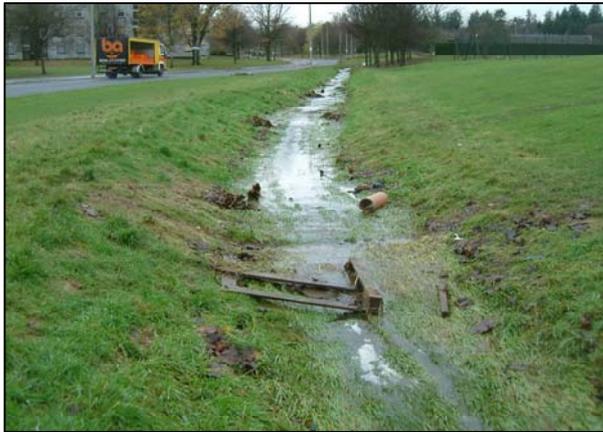
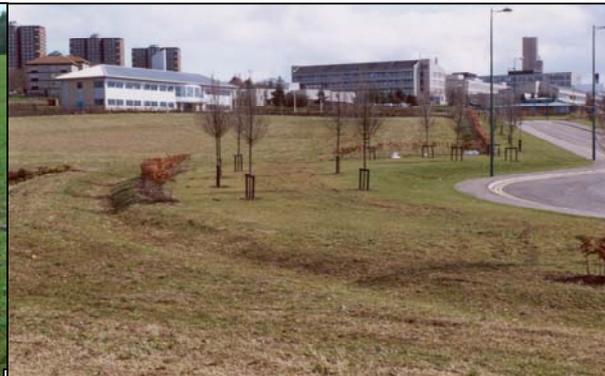
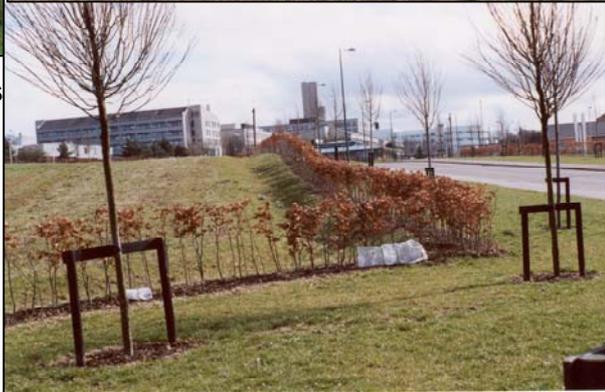
Figure 7.4 Conveyance swale arrangements

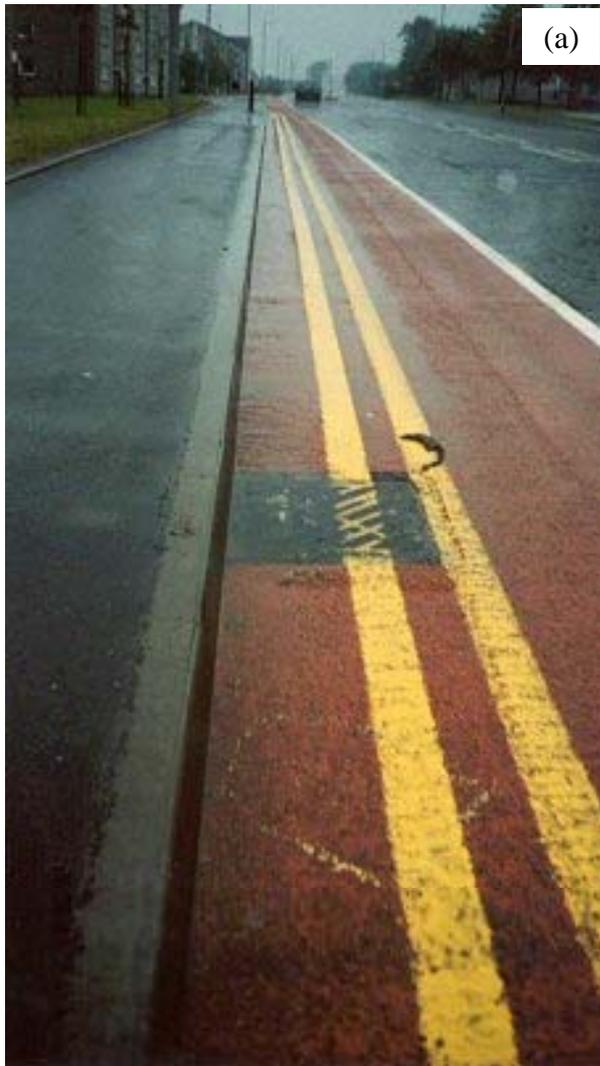
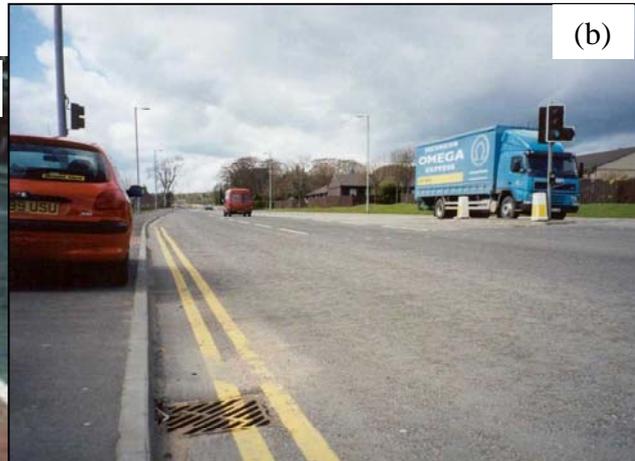
Figure 8.1 Lang Stracht Filter Drain Site – 750m long draining all of the highway and parts of some side streets.

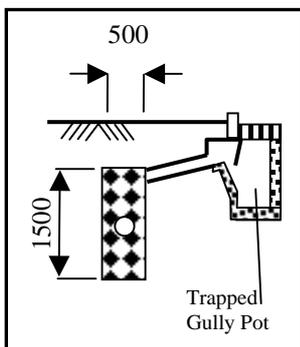
Figure 8.2 Gully Pot Detail

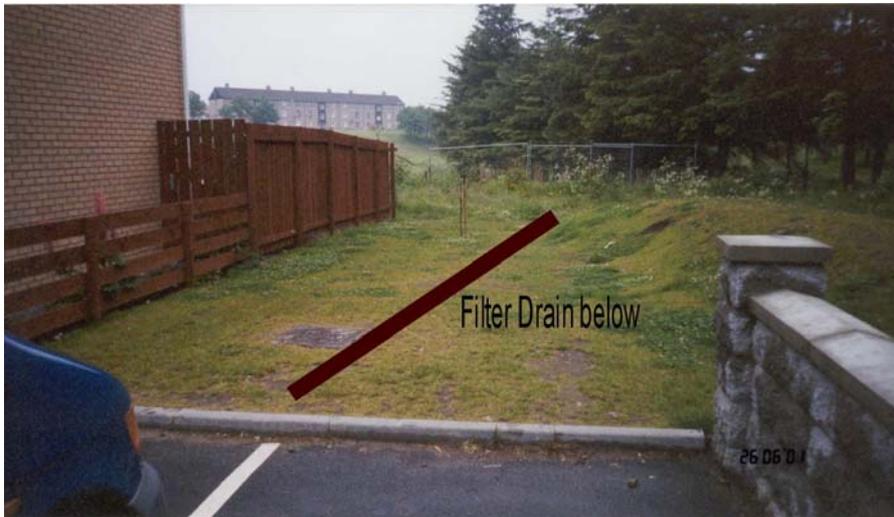
**Figure 8.3:
Example of a Filter Drain**

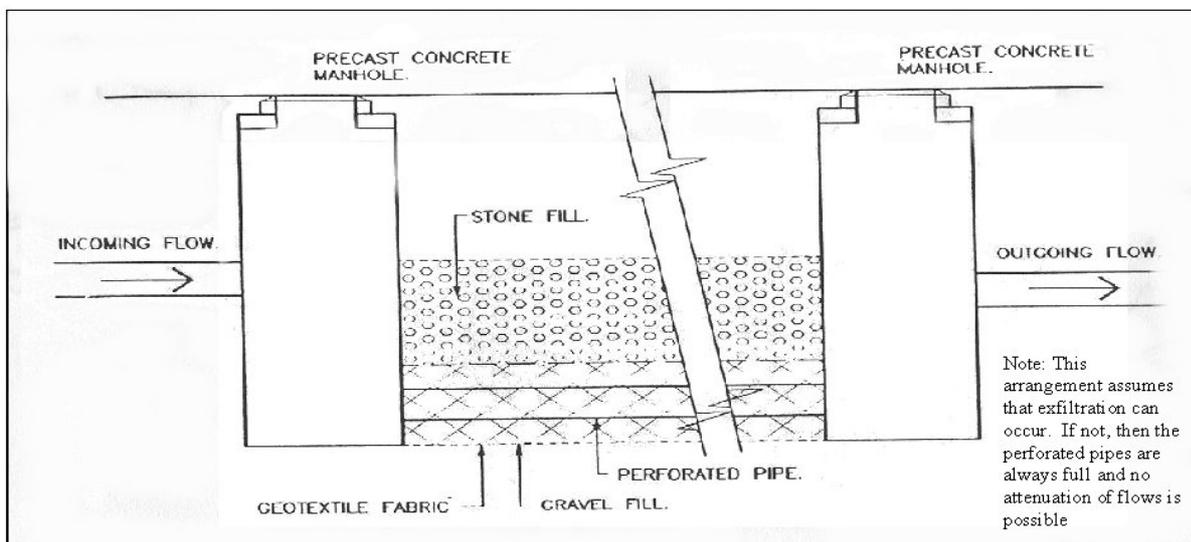
Figure 8.4: Commonly used Filter Drain Detail – But cannot perform as designed unless groundwater table is below manhole bases and the outlet pipe has a throttle.

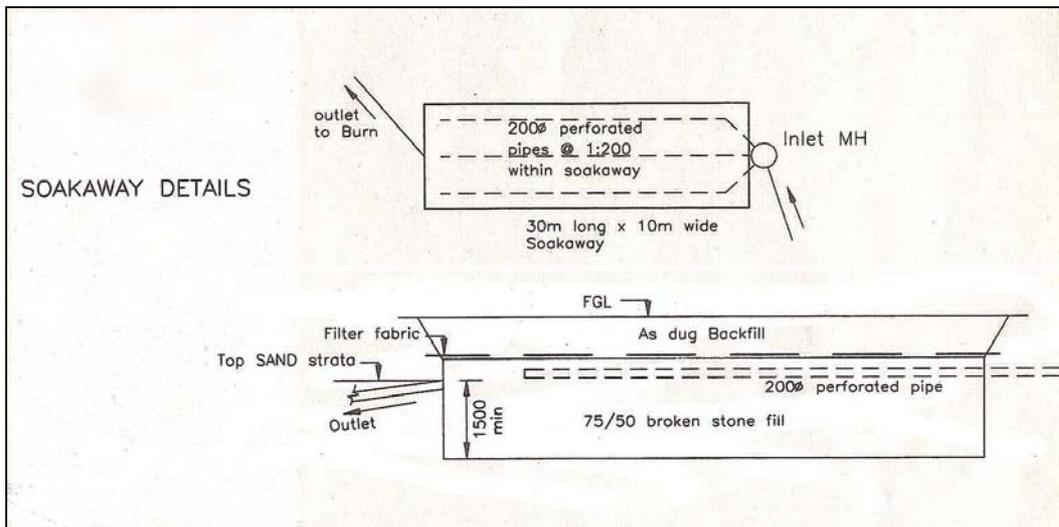
Figure 8.5: Shallow Soakaway Arrangement – Relies on being above water table

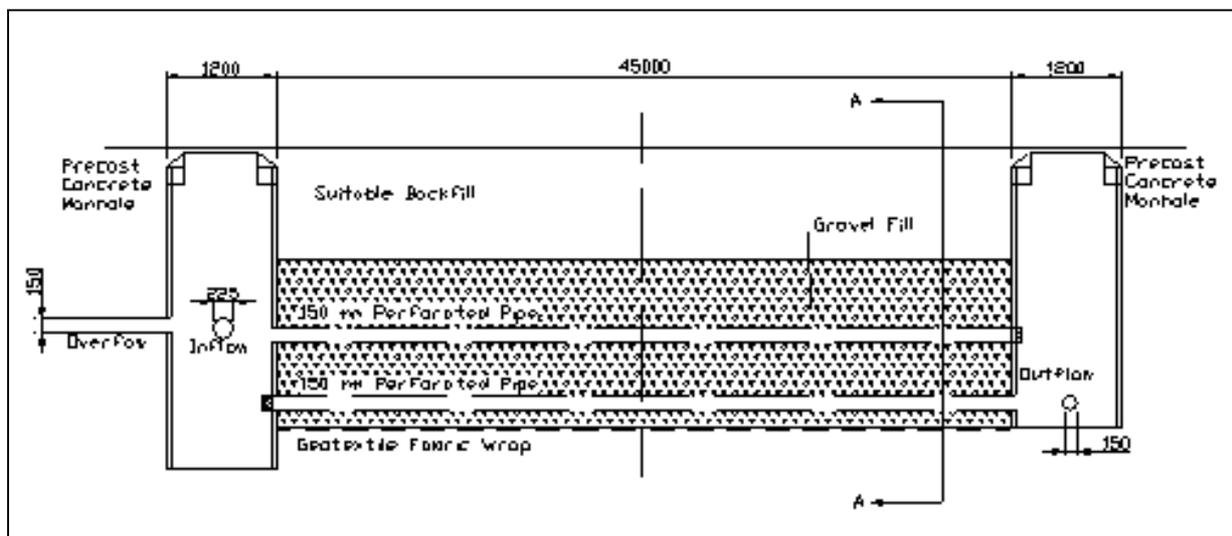
Figure 8.6: Filter Drain/ Filter Bed

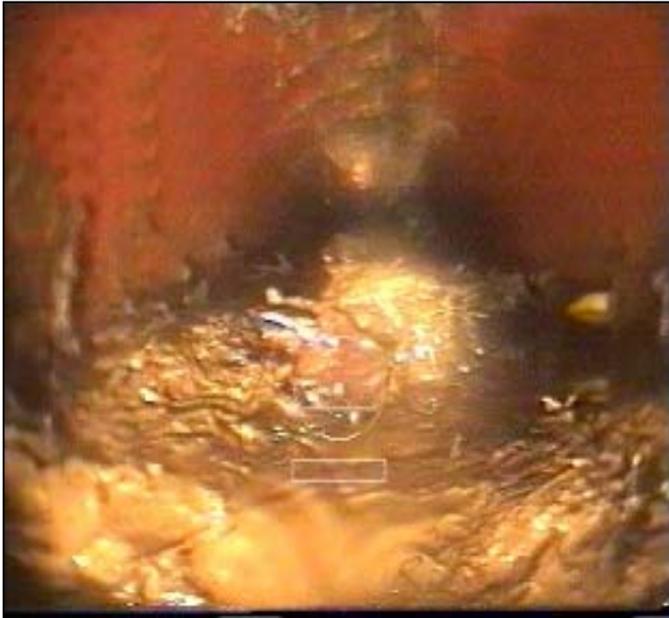
Figure 8.7: Blocked Perforated pipe at Inlet to Filter Drain/ Filter Bed

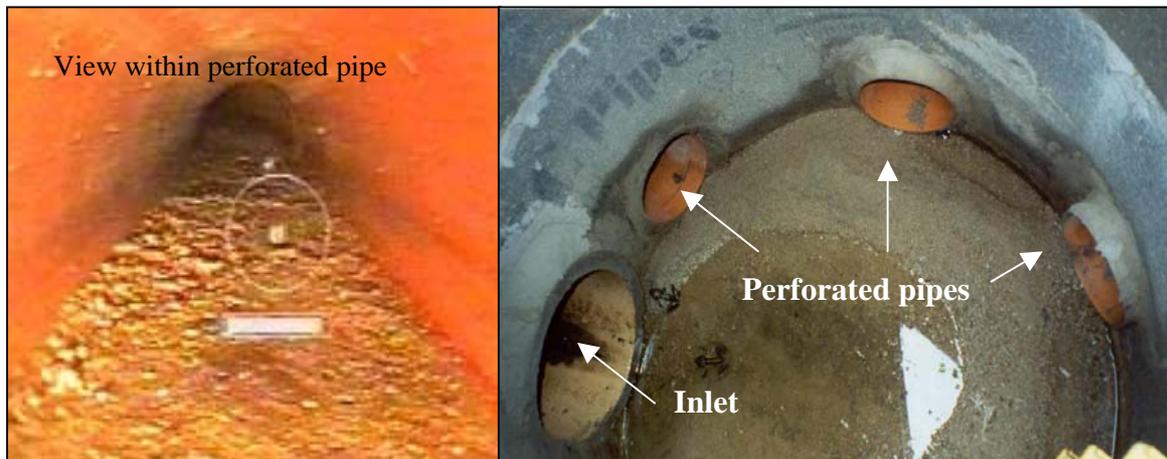
Figure 8.8: Observation of construction impact

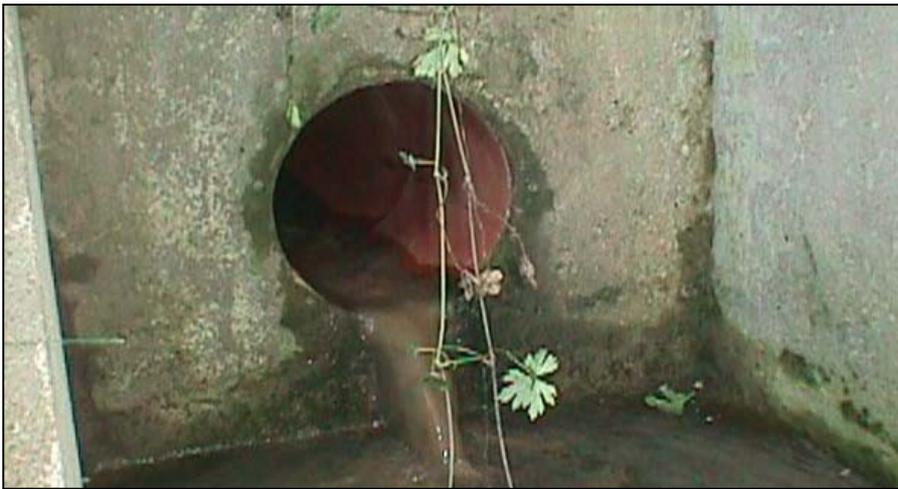
Figure 8.12: Highly turbid outflow from trench

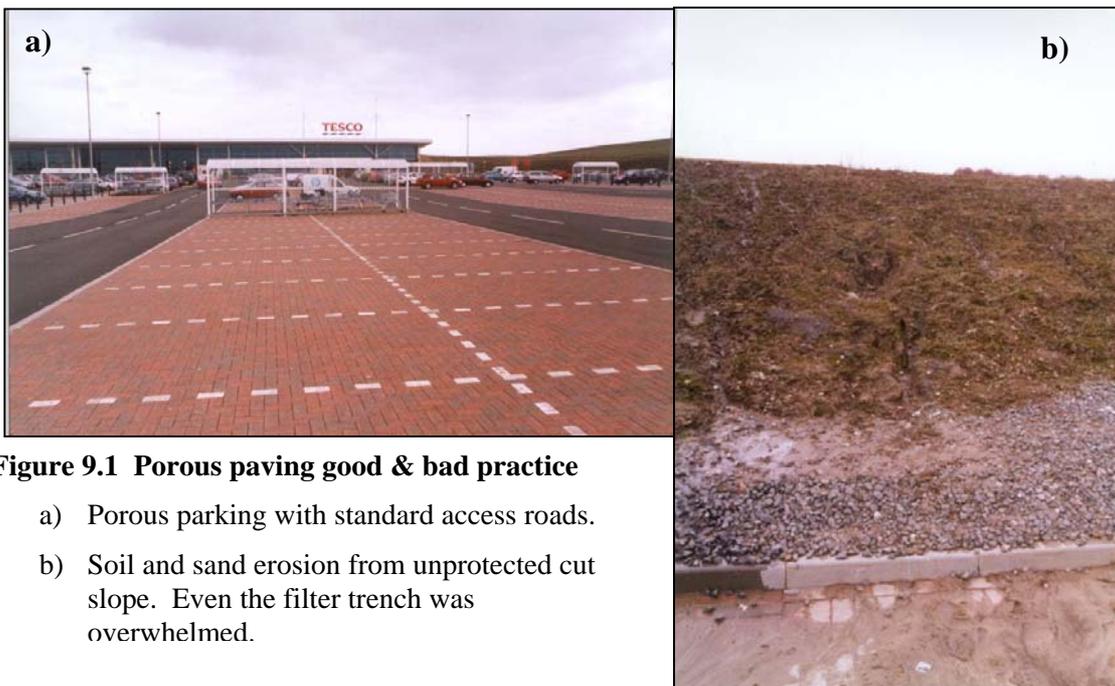
Figure 9.1 Porous paving good & bad practice

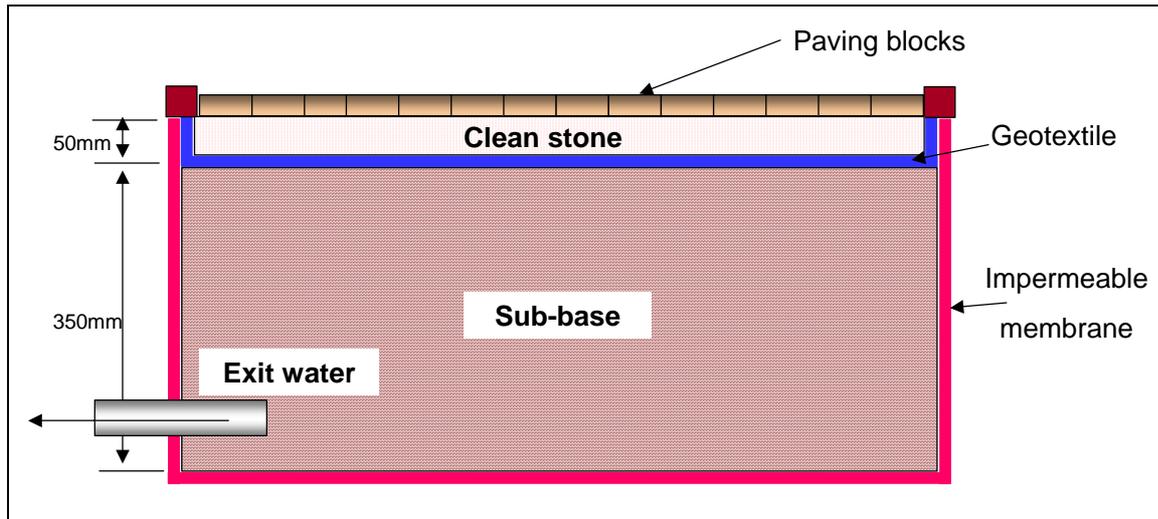
Figure 9.1 Cross-section of a typical modular block tanked system (Formpave®, 2000). (Not to scale)
