Final Report

SUDS in Scotland – The Monitoring Programme
of the Scottish Universities SUDS Monitoring Group

March 2004

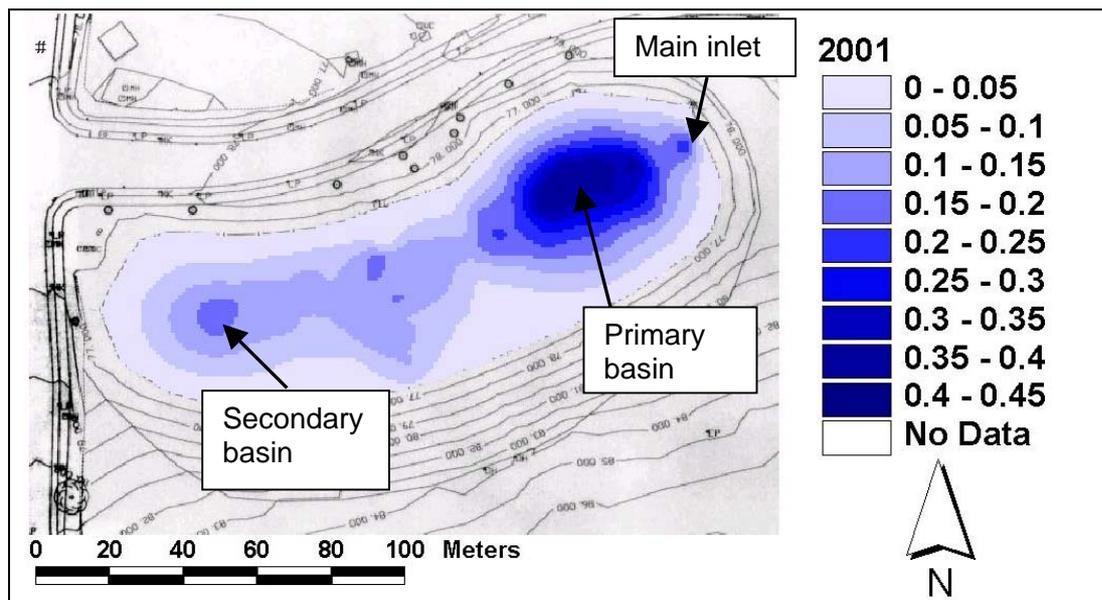
Figure 10.1. Interpolated sediment depth (m) in Linburn Pond, July 2001

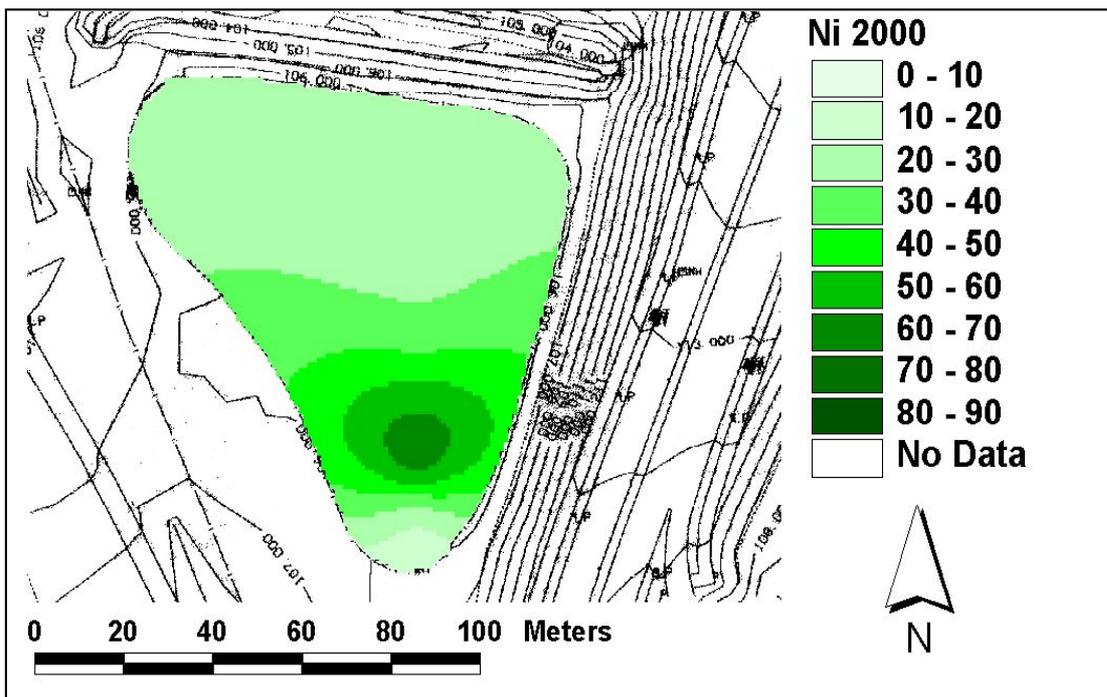
Figure 10.2 Nickel conc'ns (mg kg⁻¹ dry weight) in sediment, Halbeath Pond, July 2000

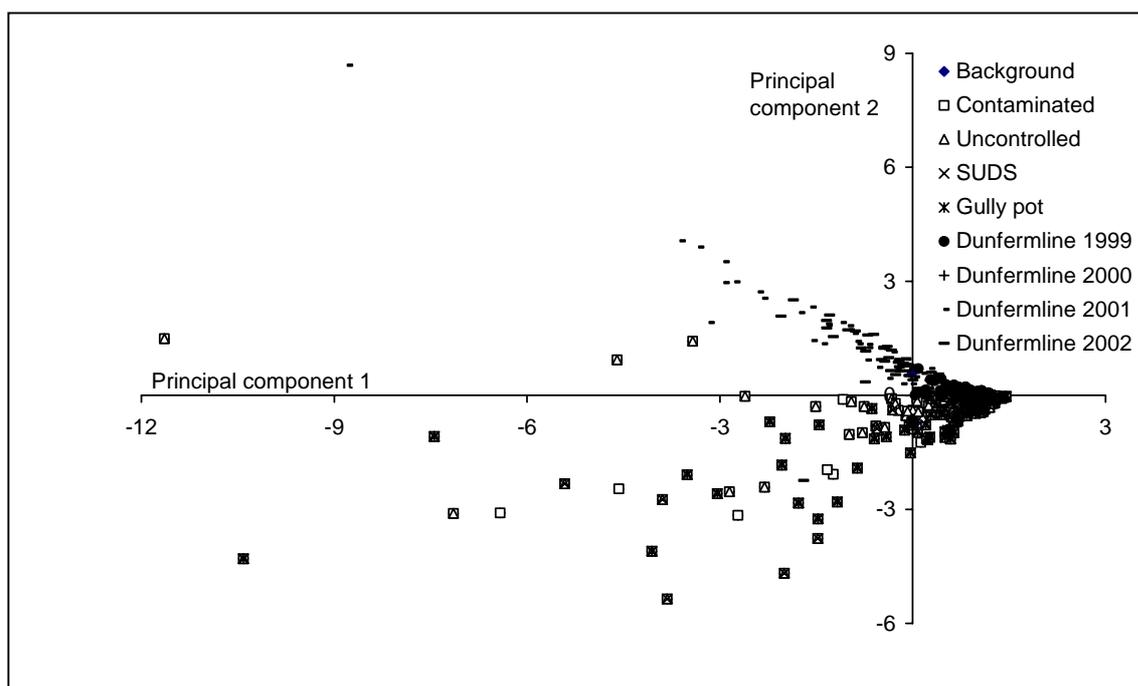
Figure 10.4 Plot of scores for principal component 2 against principal component 1 from PCA of the aquatic sediment database

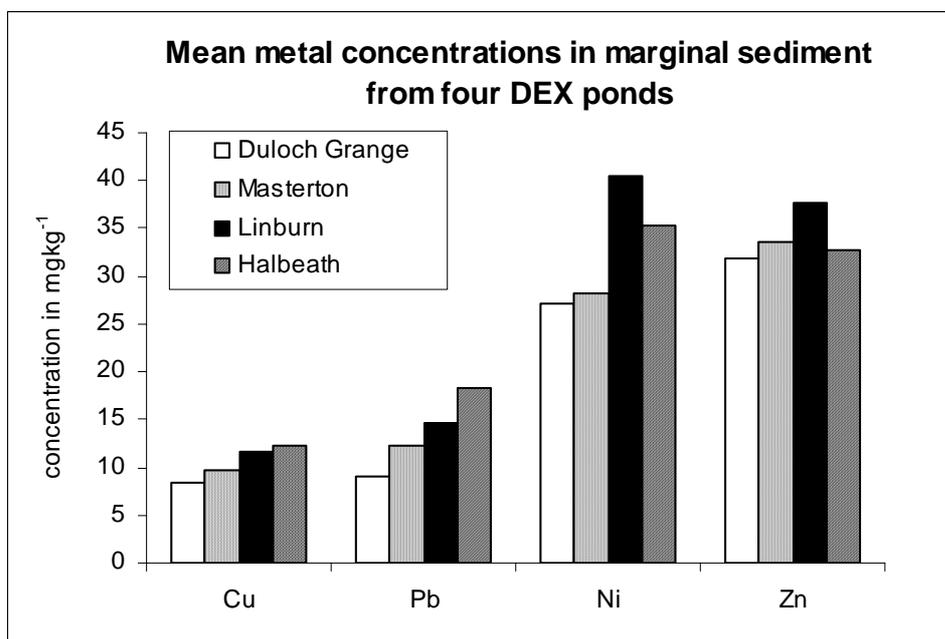
Figure 11.1 Mean Metal Concentrations in Marginal Sediment

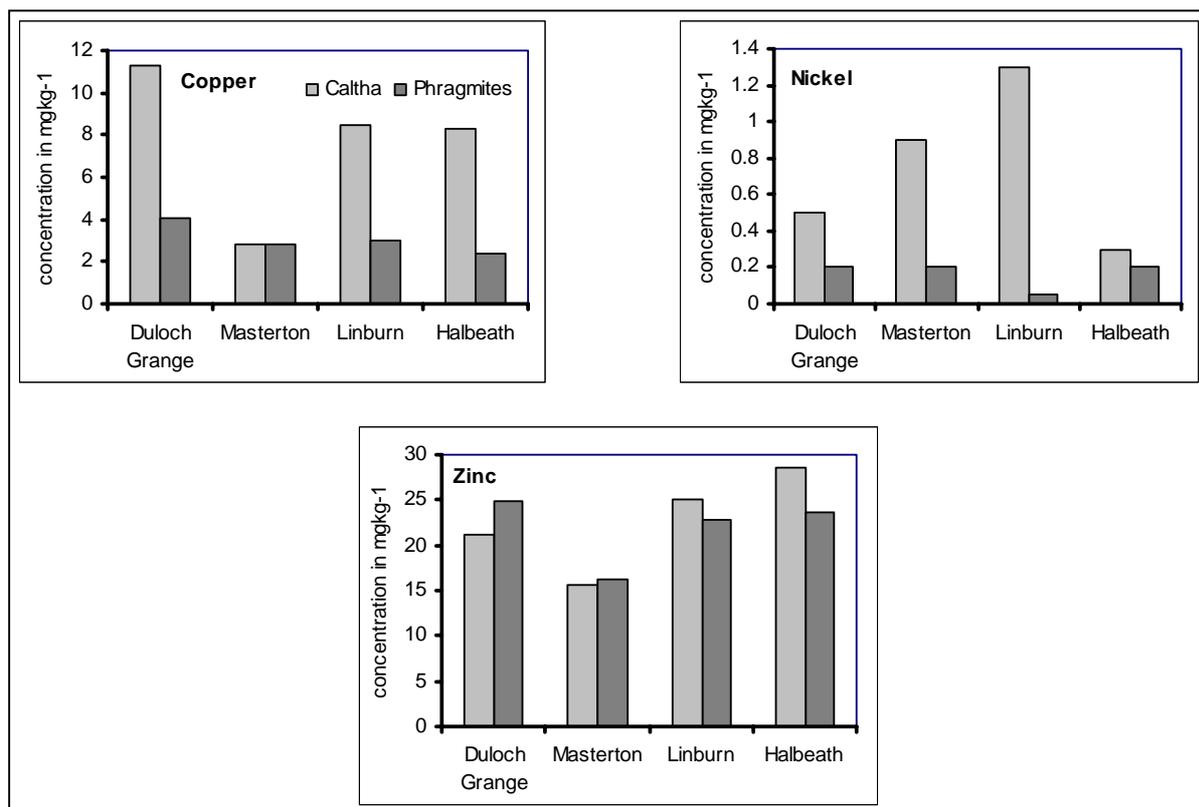
Figure 11.2 Heavy Metals Accumulations in Vegetation

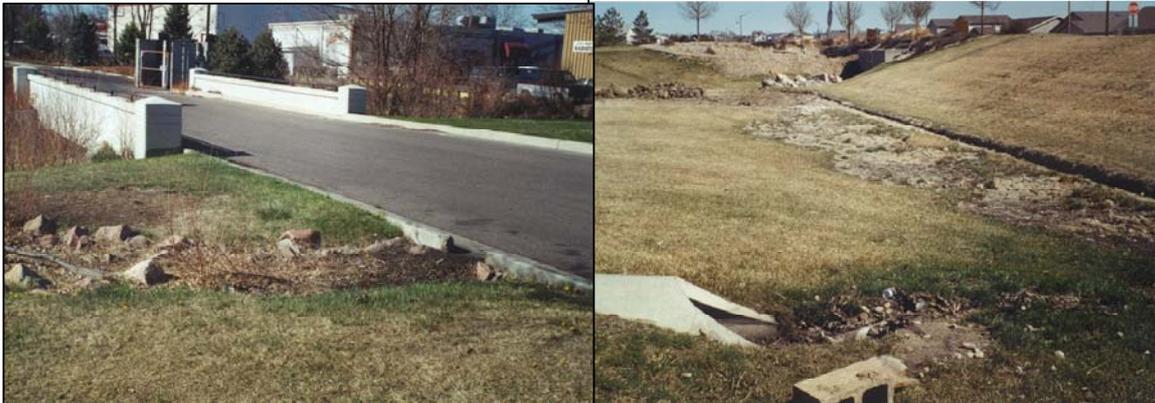
Figure 12.1 Debris in runoff channel Figure 12.2 Maintenance of detention basin base

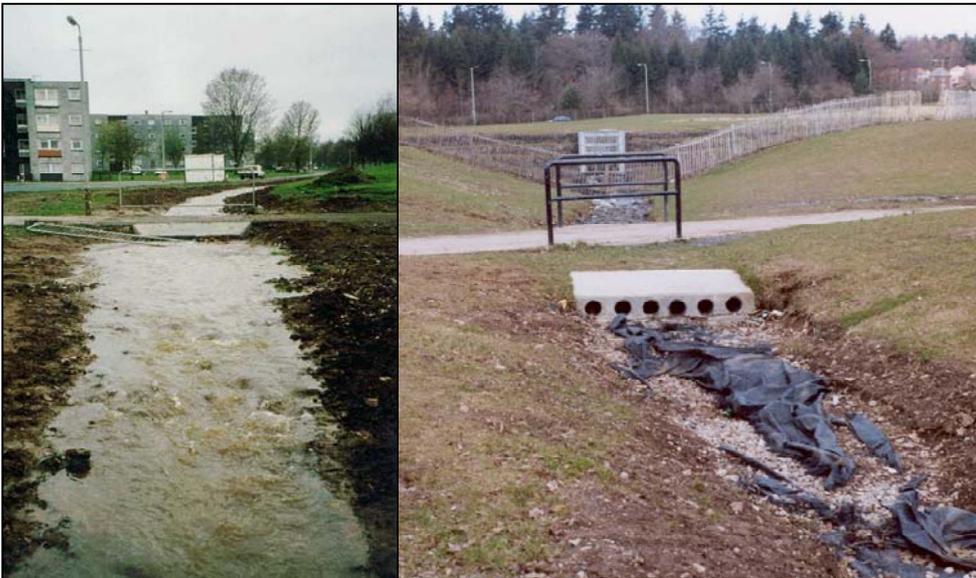
Figure 12.4 Conveyance swale, Ardler Dundee during and after heavy rainfall

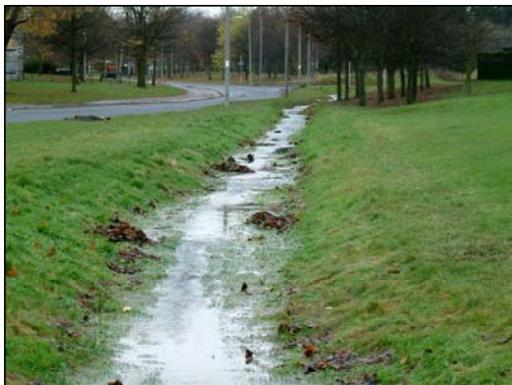
Figure 12.5 Ardler Conveyance Swale after remediation

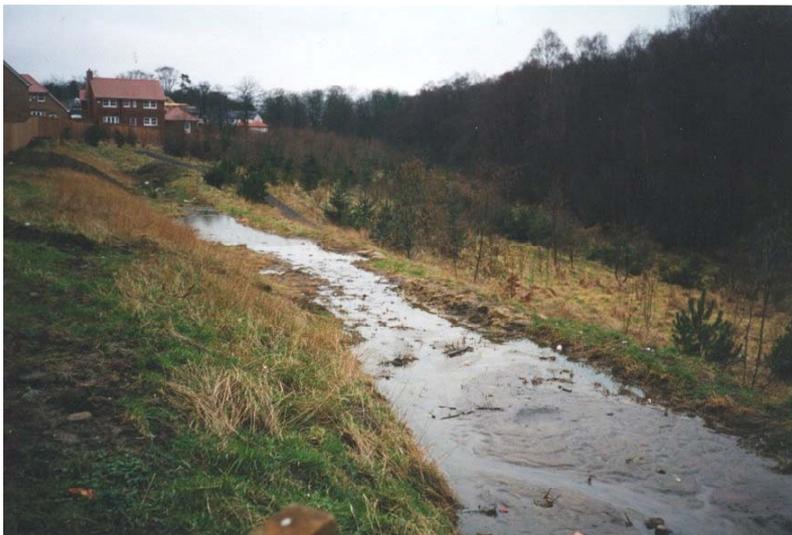
Figure 12.6 Swale/ detention basin at Murieston, Livingston overwhelmed by construction stage runoff
