## PART B

### SUDS Performance Data Summary Sheets

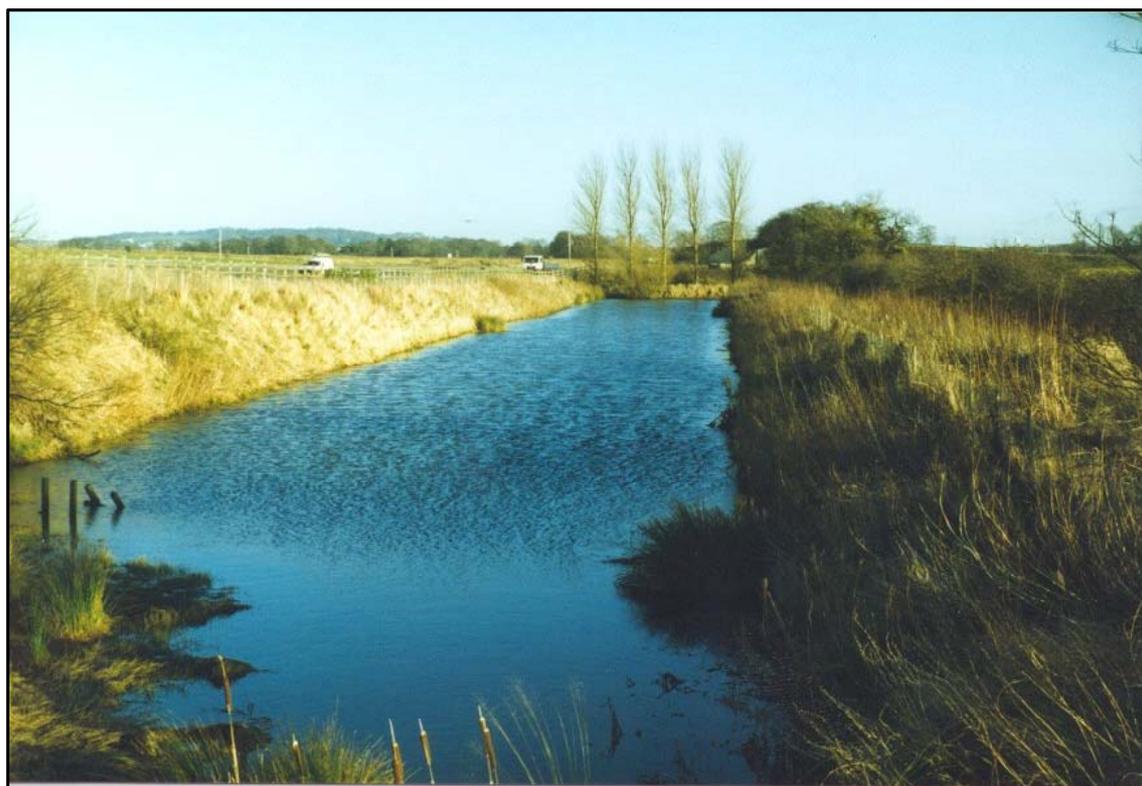
**Clayland Pond, Edinburgh**

Claylands Pond, on the western approaches of Edinburgh, receives runoff from a length of **motorway** which carries 48,000 vehicles per day. The pond, which has a volume of 2,070m<sup>3</sup>, has been in existence for over twenty years and was originally a farm irrigation pond constructed on a small stream. When the M9 motorway extension was built in 1994, the pond's location was convenient enough to be used as part of the drainage scheme. There is a small continuous flow from a stream.

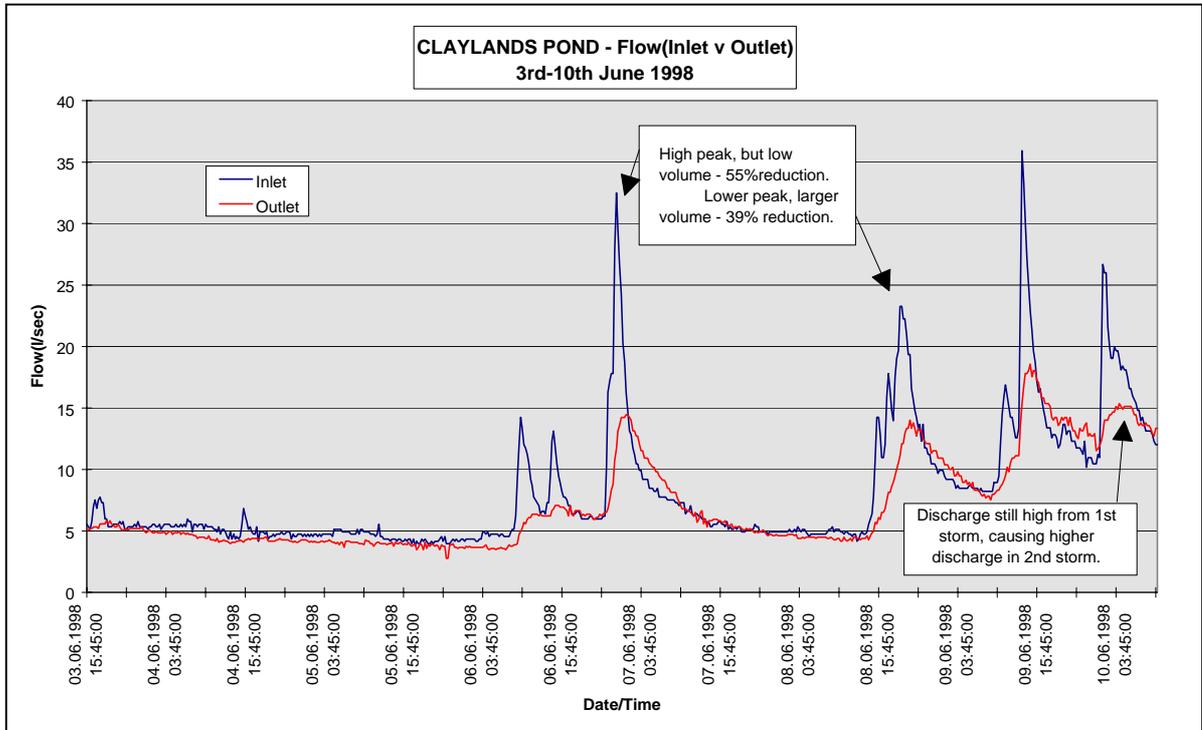
## Flowrate

Typical flowrates during a number of events are plotted below. Peak flows were reduced by an average of 43%

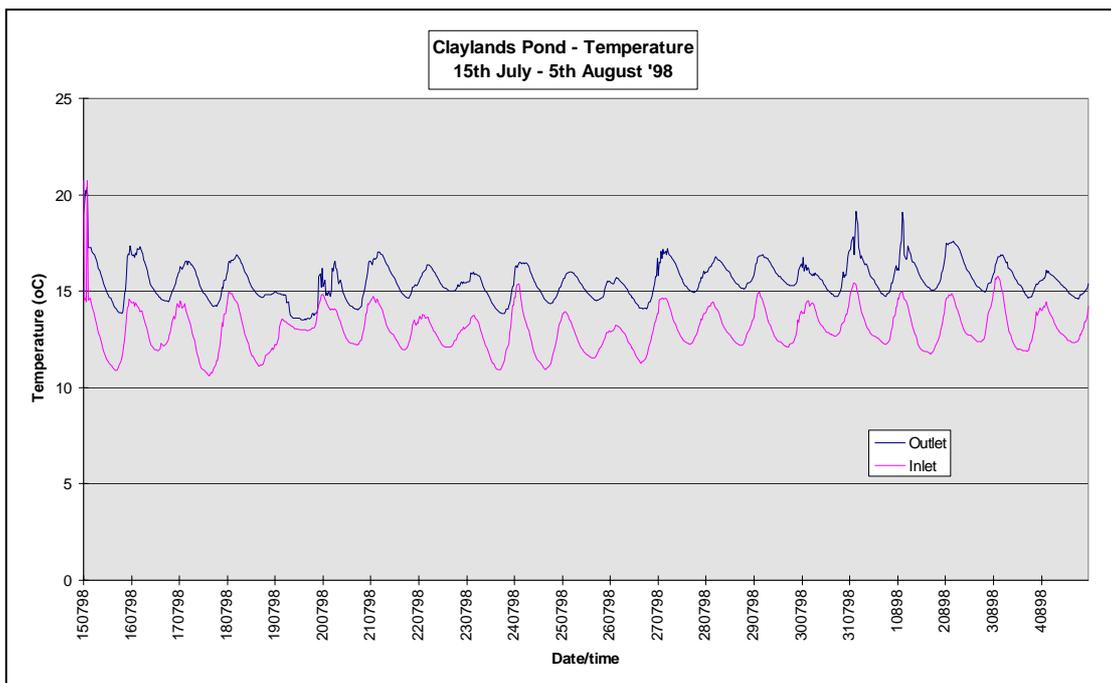
## Temperature

Diurnal variations in temperature were note in summer 1998 with a range of  $\pm 5^{\circ}\text{C}$ .

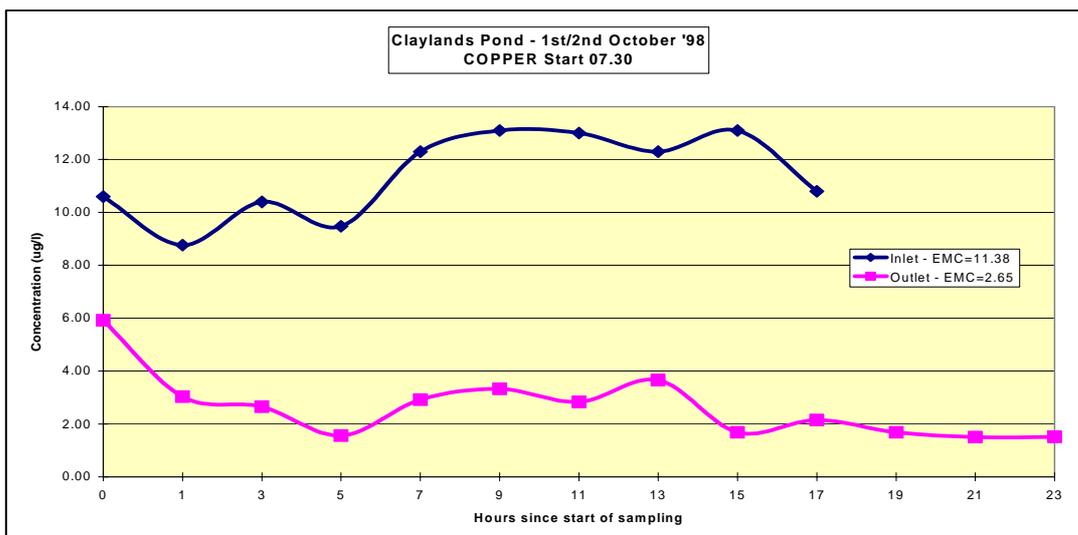
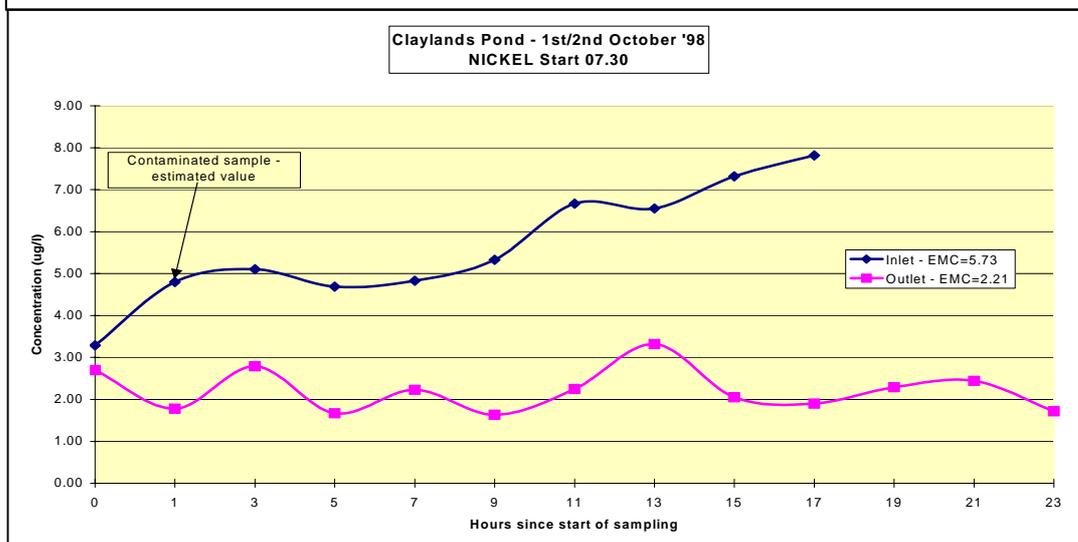
## Metals

Metals concentrations were measured from samples at inlet and outlet. Reductions in event mean concentration are shown and variations of copper and nickel are plotted. This presentation is open to the criticism that the time period considered may not have been sufficiently long to take into account all of the pollutant load. Most were calculated over a 24h time period and no significant outlet peaks were noted.

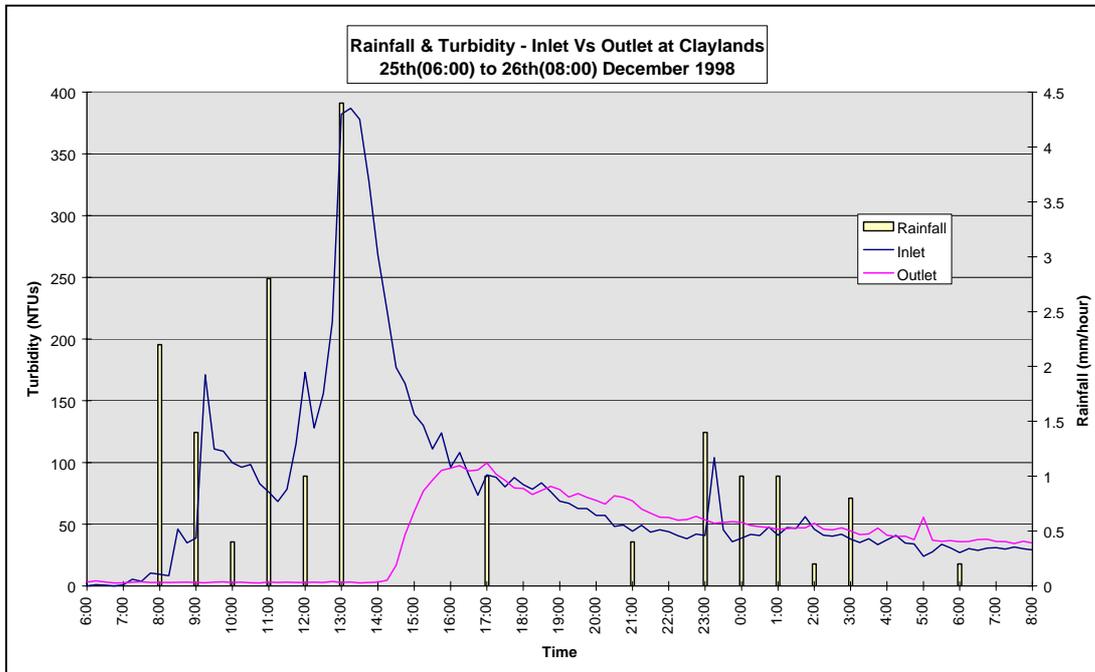
## Turbidity

Turbidity at inlet & outlet, and rainfall intensity over a two day period are shown below. This is typical of events monitored, but under dry weather conditions, outlet turbidities were observed to be higher than inlet conditions.

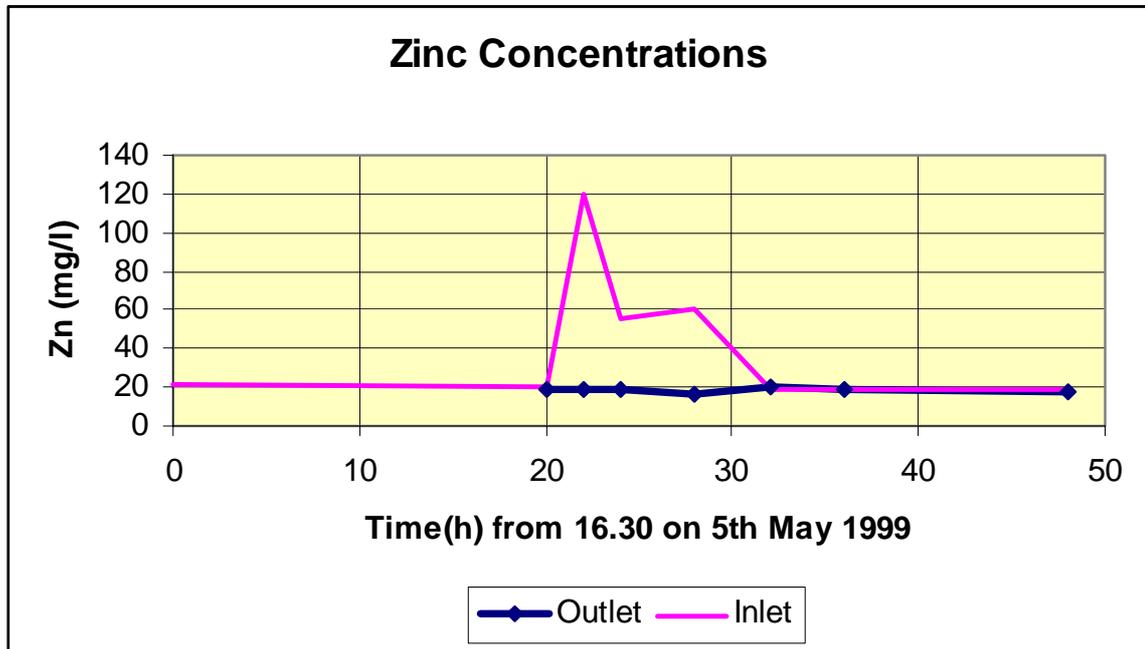
## Zinc

Zinc concentrations were recorded during one minor event;

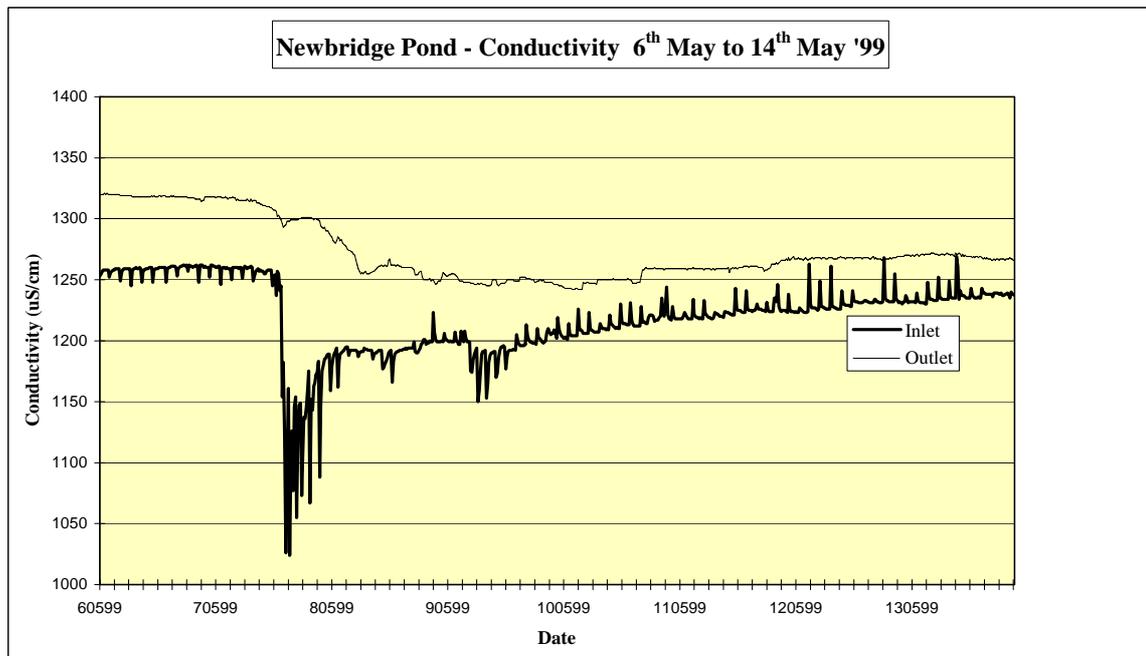
## Conductivity

Data from sondes installed at inlet and outlet are plotted below. A low conductivity flush occurred with rainfall on 8<sup>th</sup> May 1999 and the attenuation of concentration may be observed in the outflow.

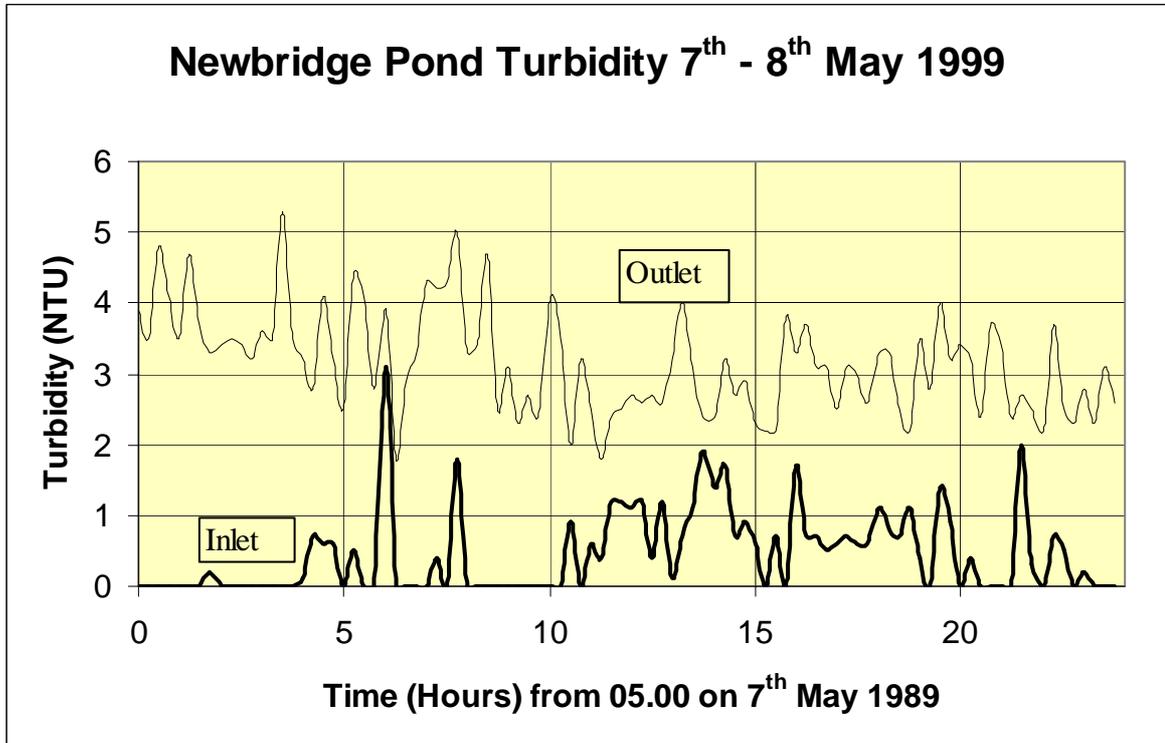
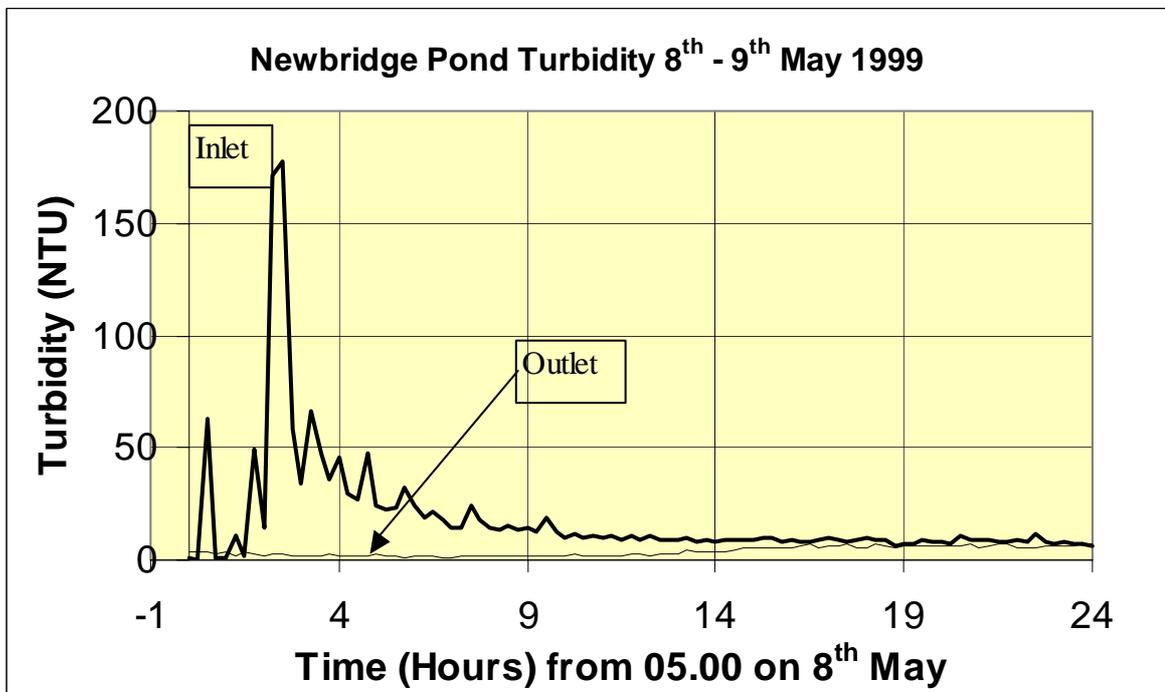
## Turbidity

Under low flow conditions, as shown on 7<sup>th</sup> – 8<sup>th</sup> May 1999, outlet turbidities at the pond outlet are normally higher than at the inlet, reflecting biological and other activity in the pond. The plot from 8<sup>th</sup> – 9<sup>th</sup> May indicates that one principal function of this pond is the attenuation of pollutants.

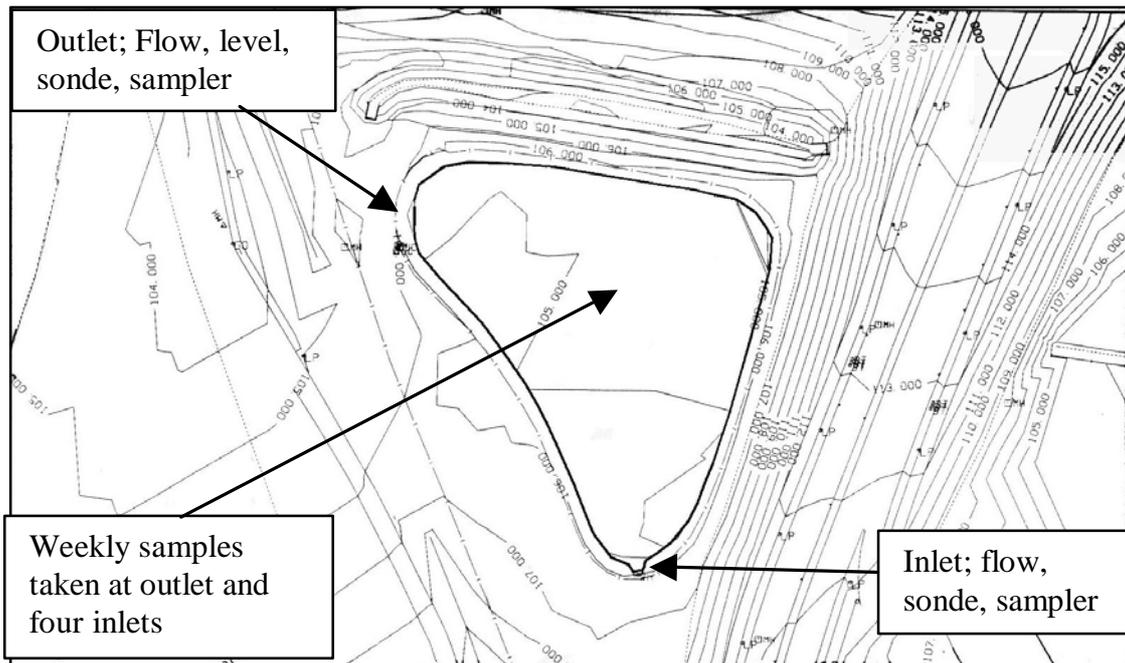
Figure 3.1 Plan of Halbeath Pond

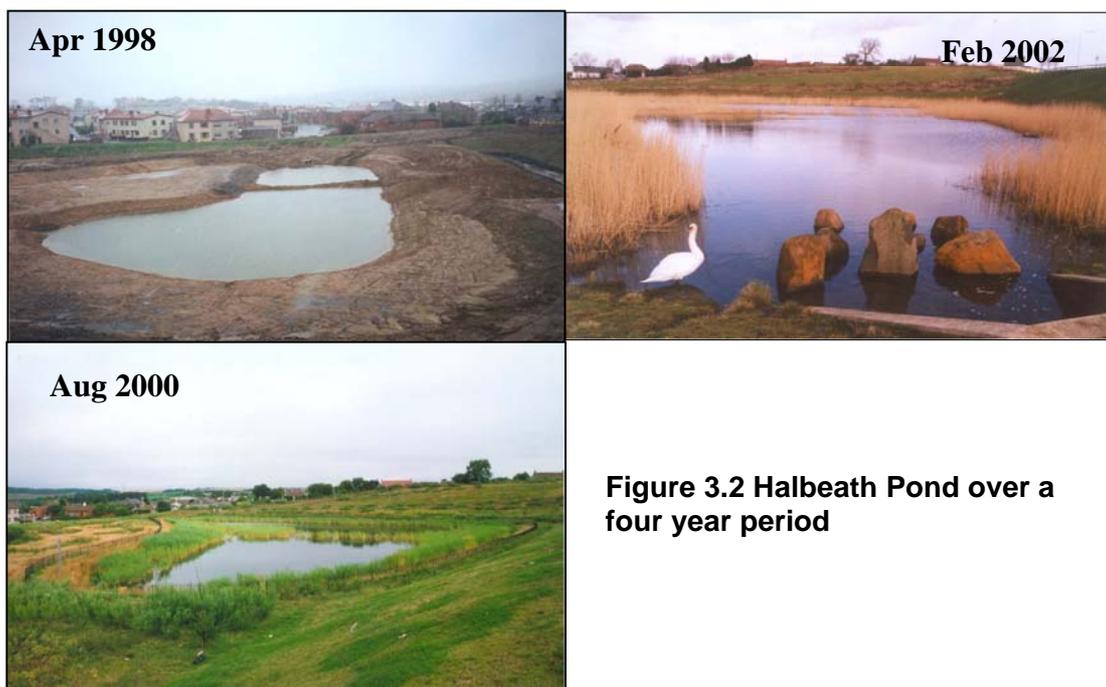
Figure 3.2 Halbeath Pond over a four year period

Halbeath pond was constructed at the end of 1997, aquatic planting for the ponds was carried out during June and July 1998. Halbeath pond catchment area is 13.5 ha with very low gradients. Runoff is from a leisure park and road surfaces. To date the built up surface area comprises approximately 60 % of the catchment total. Halbeath pond has a total surface area of  $\approx 3200 \text{ m}^2$  and a volume of  $4600 \text{ m}^3$ . Data suggest that the ponds remove orthophosphate and total oxidised nitrogen, the best removal rates being during the summer months, but information on nitrogen removal is inconclusive. There appears to be no removal of chlorides in the retention ponds, but data show that conductivity at the outlets is usually much lower than at the inlets, probably due to dilution. Removal of suspended solids is excellent, always below 30 mg/l and below 32 NTU turbidity, although sediment loads of 32000 mg/l have been measured at the inlet. Table 3.1 shows water quality information obtained during four weeks of sampling.

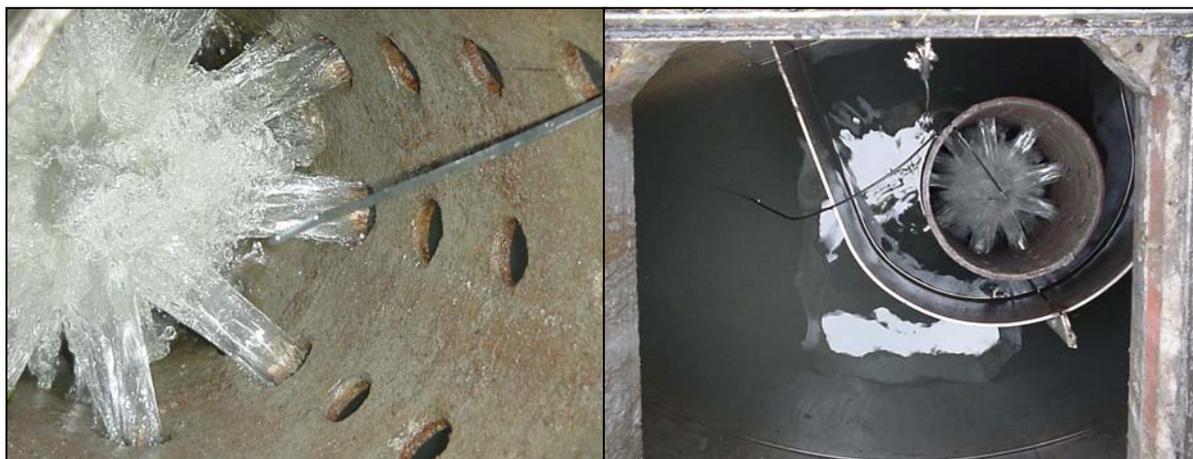
**Figure 3.3 Outlet Details – located in a Manhole**

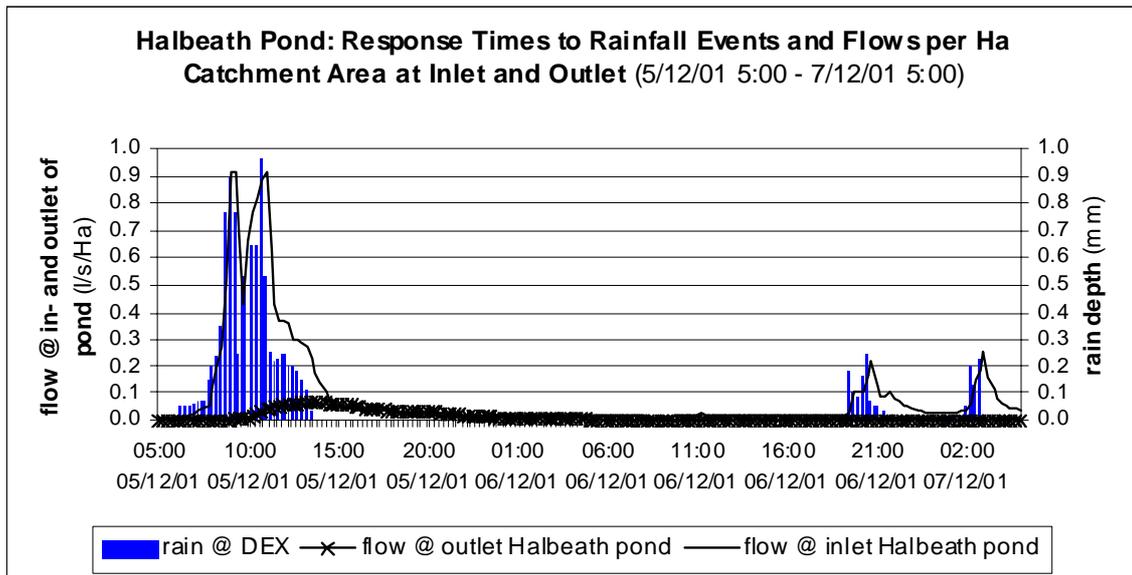
**Figure 3.4 Comparison of flows at inlet and outlet at Halbeath Pond**

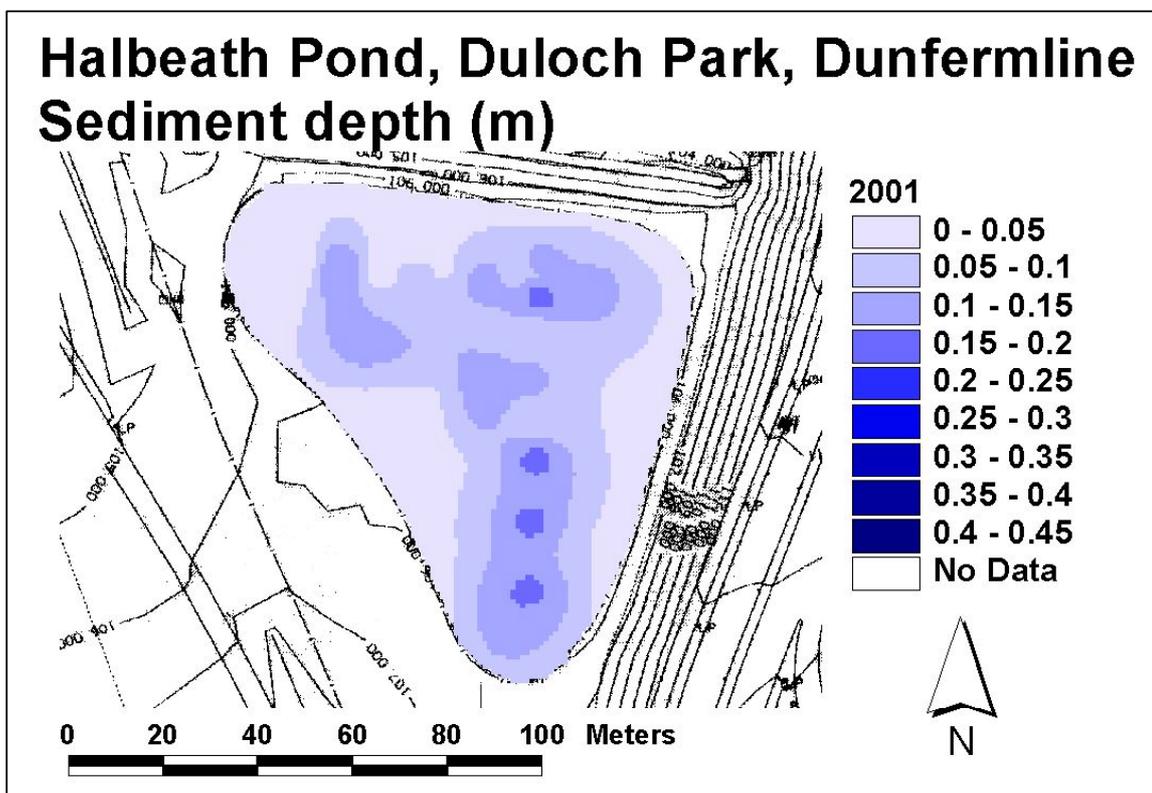
**Figure 3.5 Halbeath Pond Sediment Accumulation 2001**

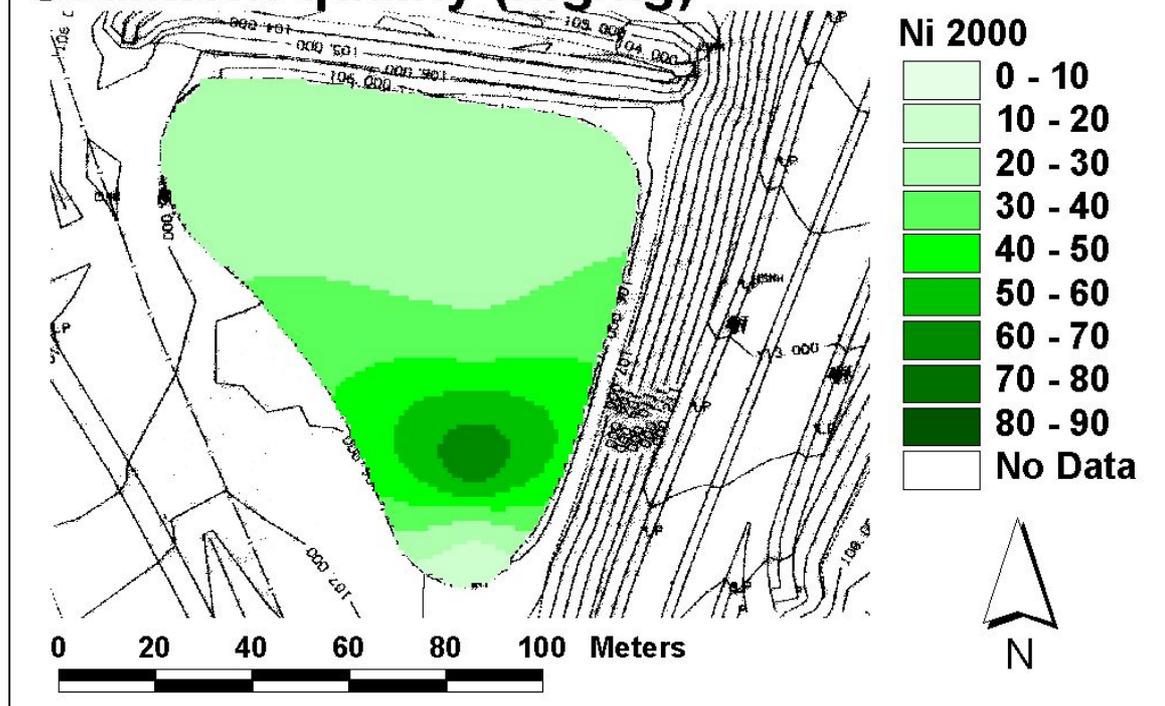
Figure 3.6 Halbeath Pond Sediment Quality - Nickel 2001

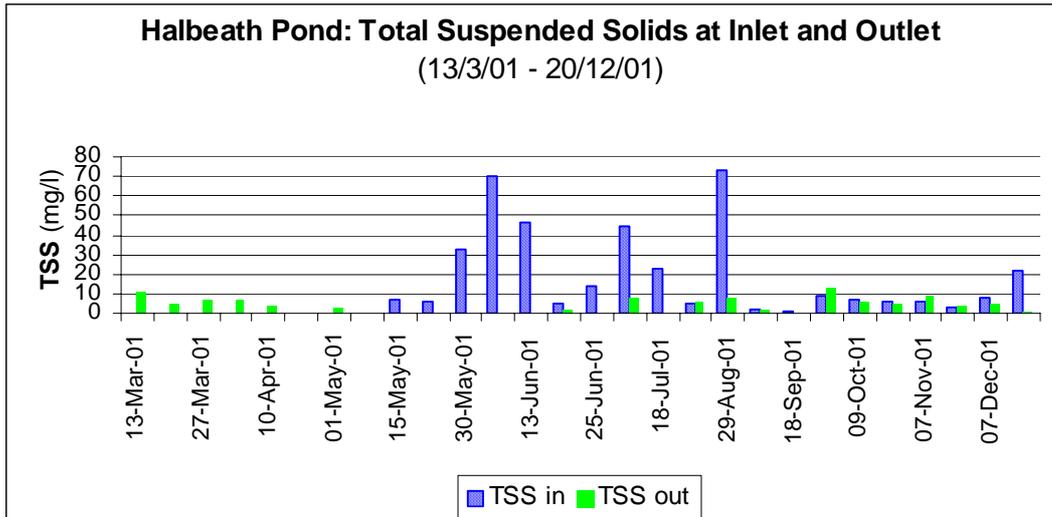
**Figure 3.7 Comparison of Inlet and Outlet Concentrations (Typical)**

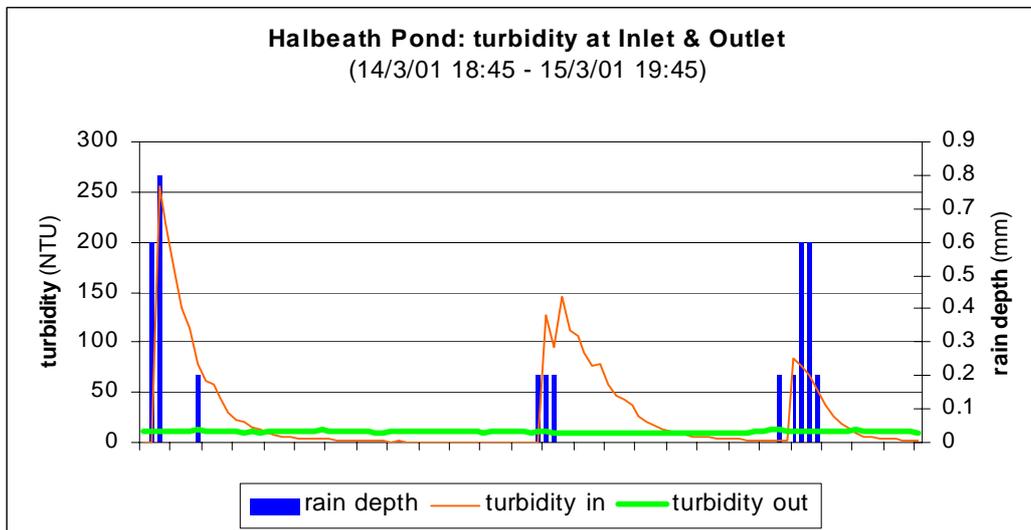
**Figure 3.8 Typical inlet and Outlet Turbidities**

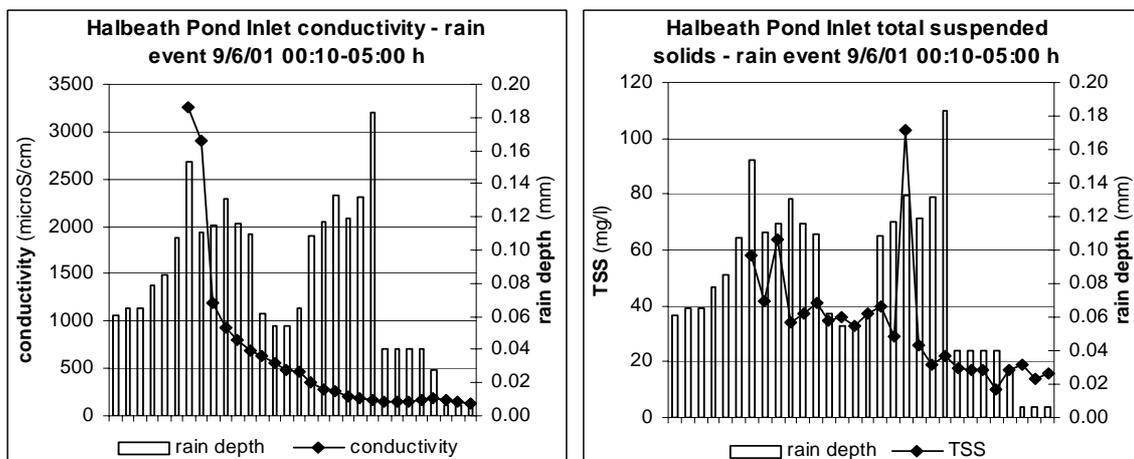
**Figure 3.9 Inlet TSS and Conductivity During an Event**

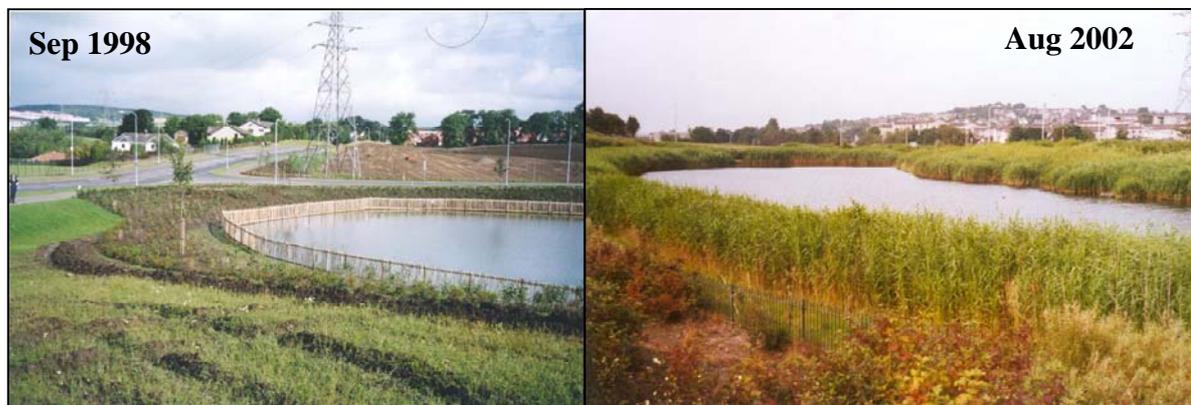
**Figure 4.2** Linburn Pond over a four year period

Linburn pond was constructed at the beginning of 1998. Aquatic planting was carried out during June and July 1998. There are four inlets and one outlet. All inlets draining development areas have detention basins upstream. The catchment area is 67.5 ha and there are six upstream detention basins interconnected by pipes. The surface area is  $\approx 10,200 \text{ m}^2$  and the volume is  $15,495 \text{ m}^3$ .

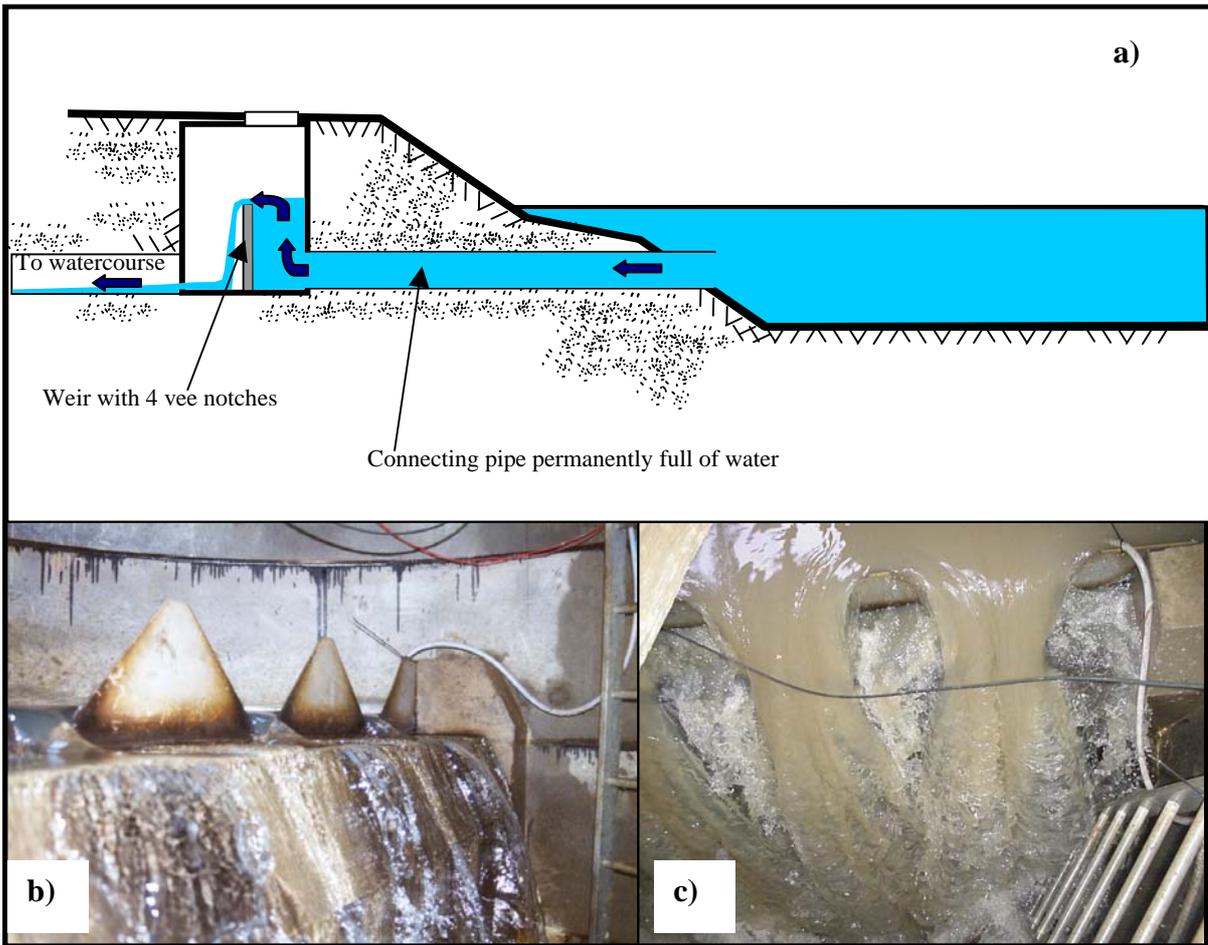
**Figure 4.3 Linburn Pond Outlet Weir Details**

- a) Section through outlet pipe.
- b) Three of the four vee notches during low flow conditions.
- c) High flow over outlet weir from above.

The outlet control structure is located entirely underground in a large manhole. The chamber may be seen in Figure 4.3 a)

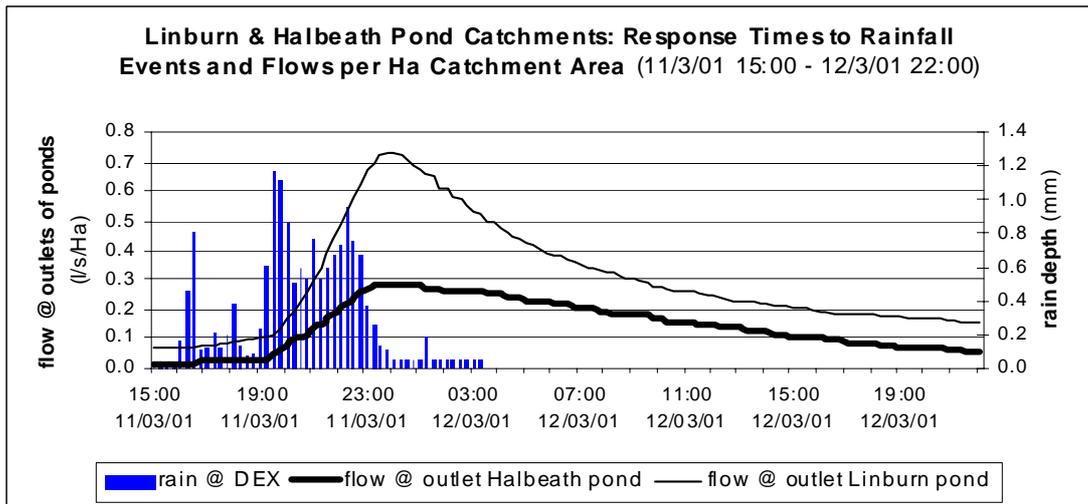
**Figure 4.4 Flows at outlets of Linburn & Halbeath ponds showing flow attenuation**

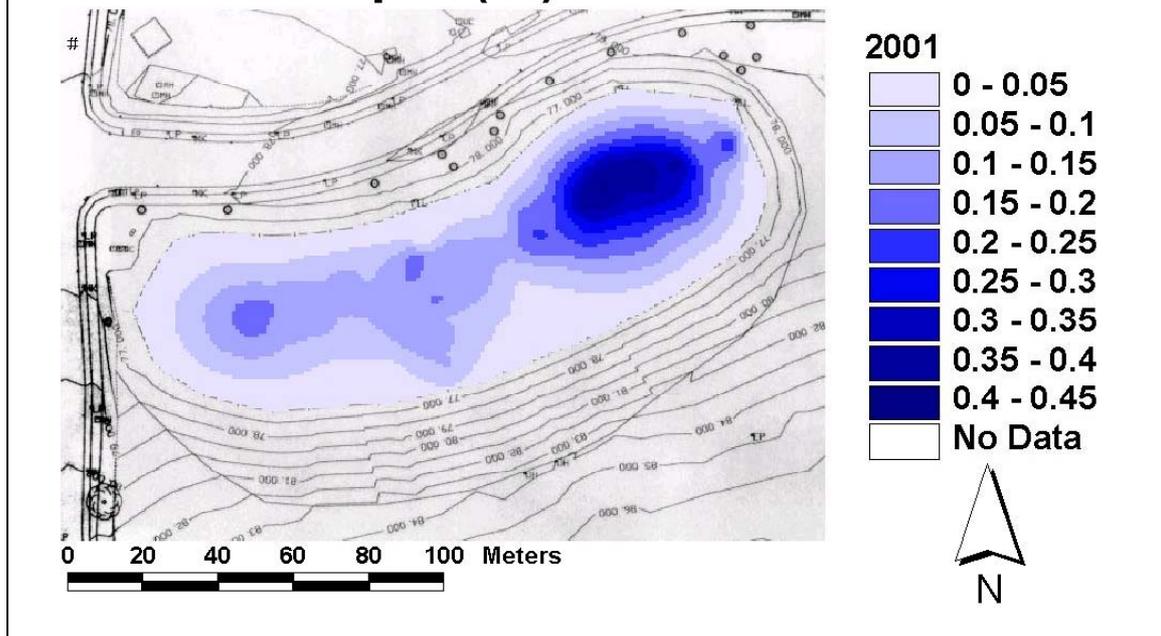
**Figure 4.5 Sediment Accumulation 2001 (Thanks to Kate Heal and Wilcon Homes)**

This particular pond is likely to have relatively low rates of sediment input and deposition because all inflow passes through detention basins upstream apart from one site which was under development during monitoring.

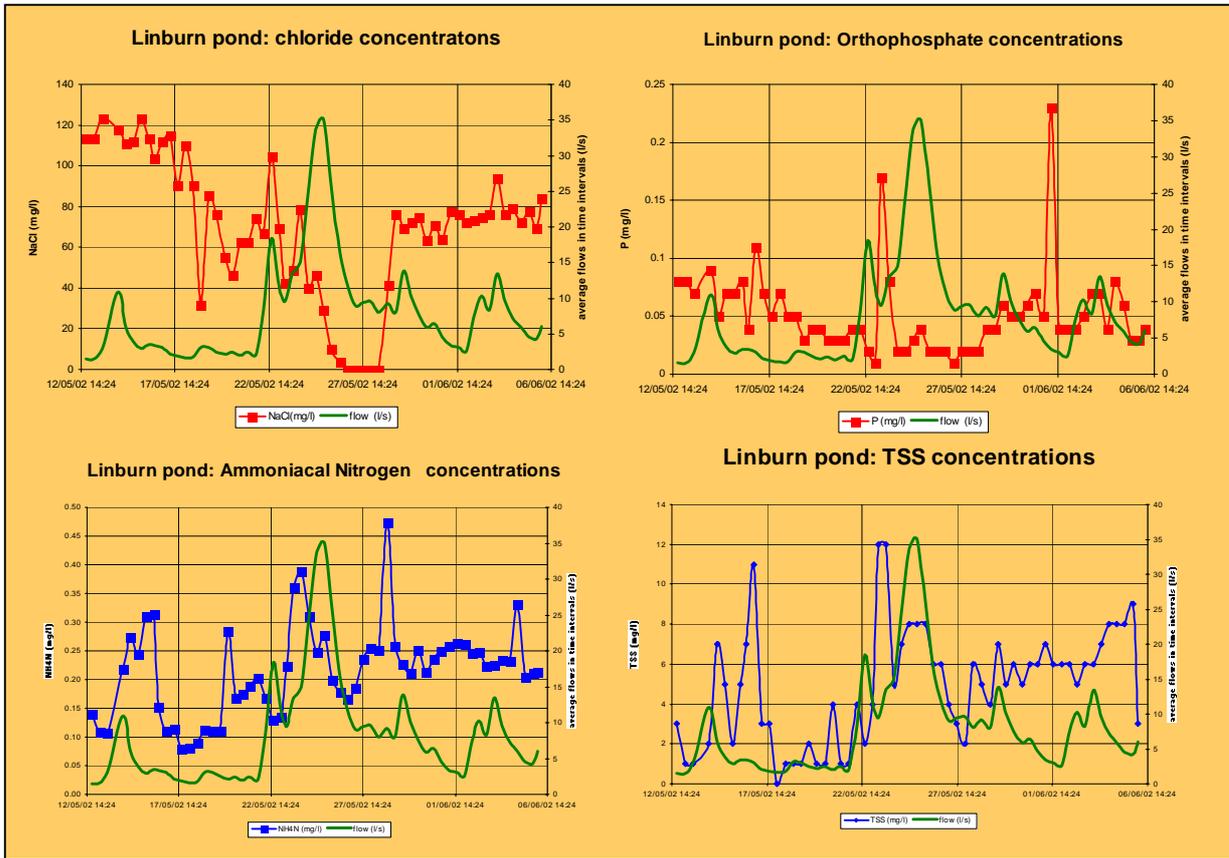
Figure 4.6 Linburn Pond Outlet - Flows and Concentrations during a four week period 12th May to 6<sup>th</sup> June 2002

Figures 4.6 and 4.7 are included to illustrate the consistency of the concentrations of the outflow from this pond. There are five separate inlets to the pond and it was not possible to monitor each. Consequently, the graphs are included to give typical concentrations of typical determinands at the outlet.

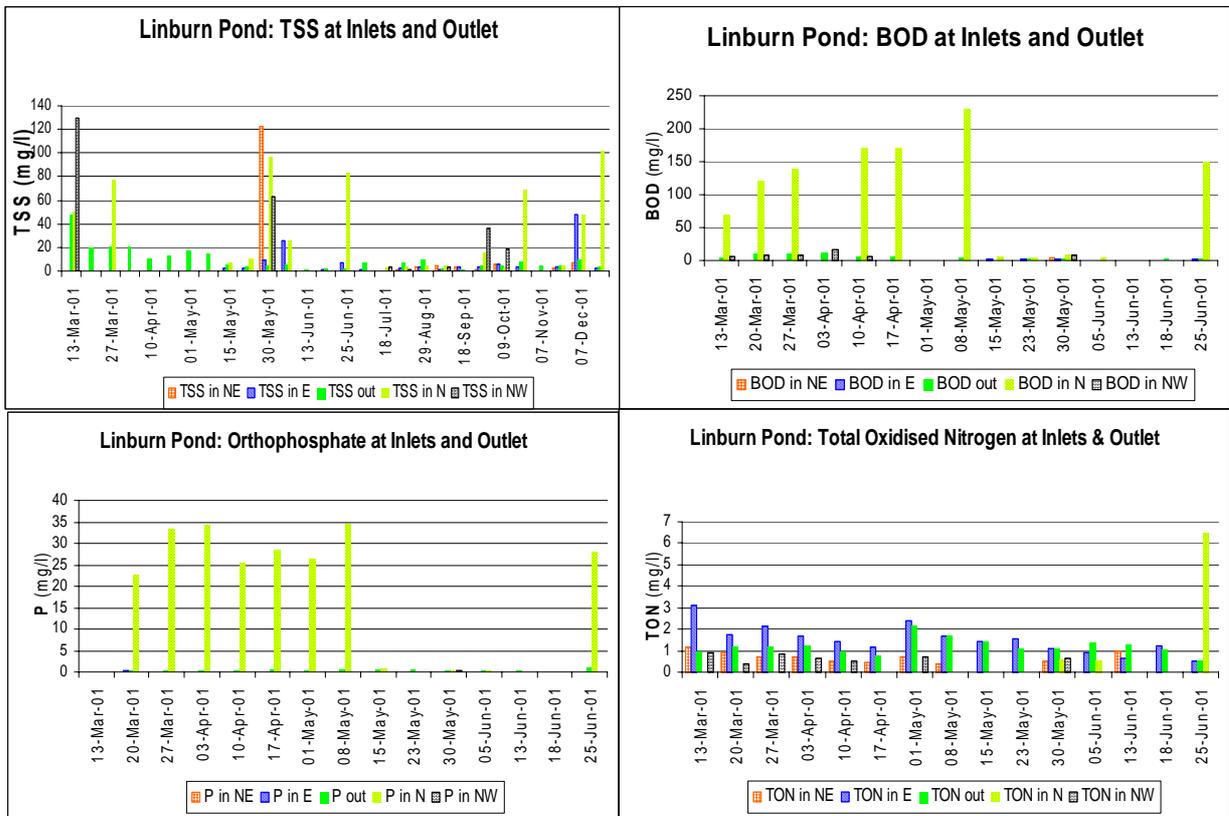
Figure 4.7 Linburn Pond Inlets and Outlet – Concentrations Measured from spot samples March – June 2001

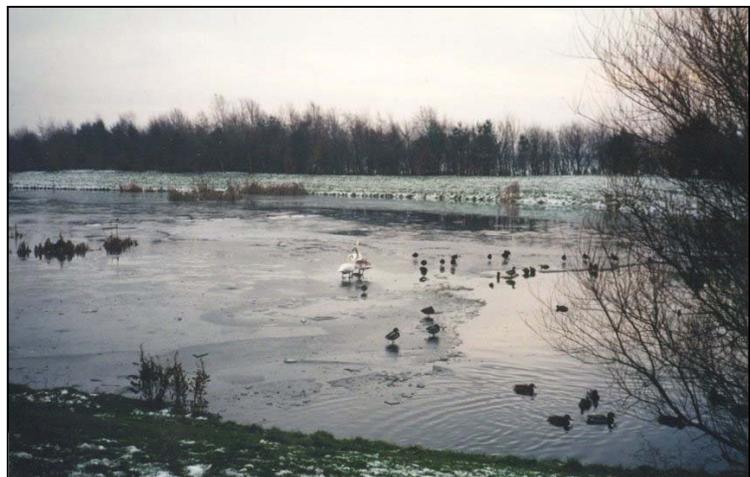
**Figure 5.2 Stenton Pond in Winter**

Several monitoring programmes have been carried out at Stenton Pond. This has included routine baseline sampling for an extended period, and targeted periods to monitor specific events. Data are presented on an event by event basis since this best illustrates the pond performance.

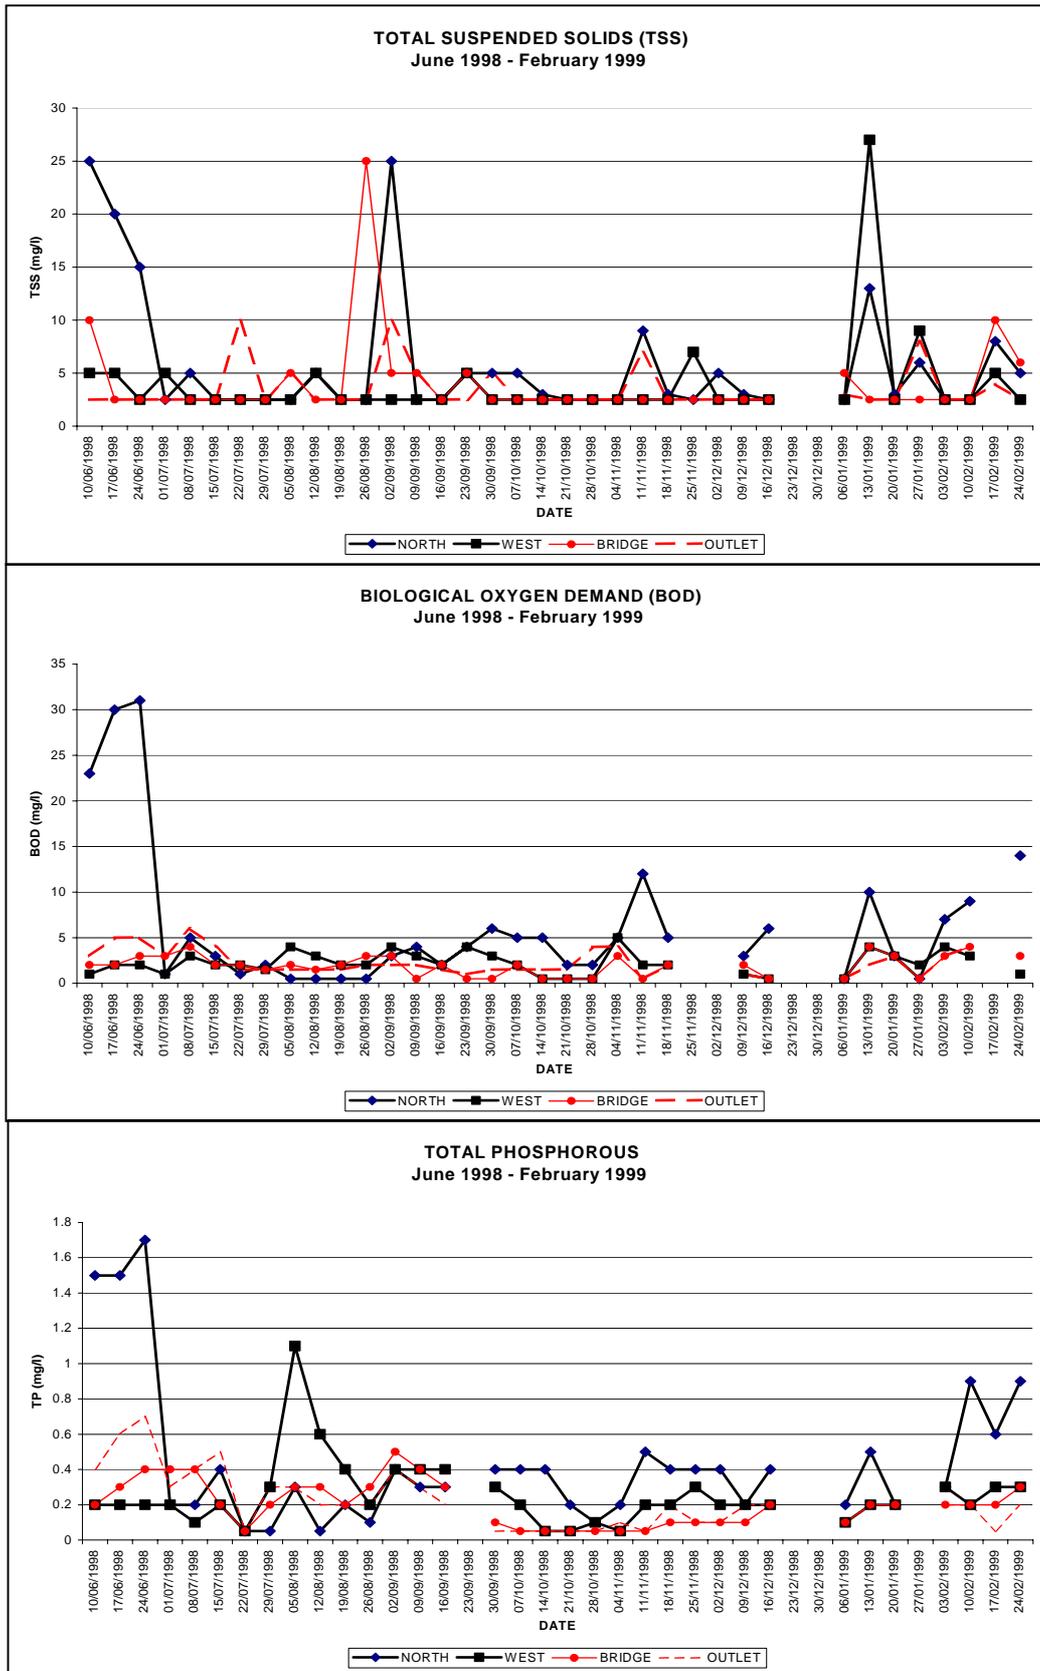
Figure 5.3 Stenton Pond – Routine Monitoring Results

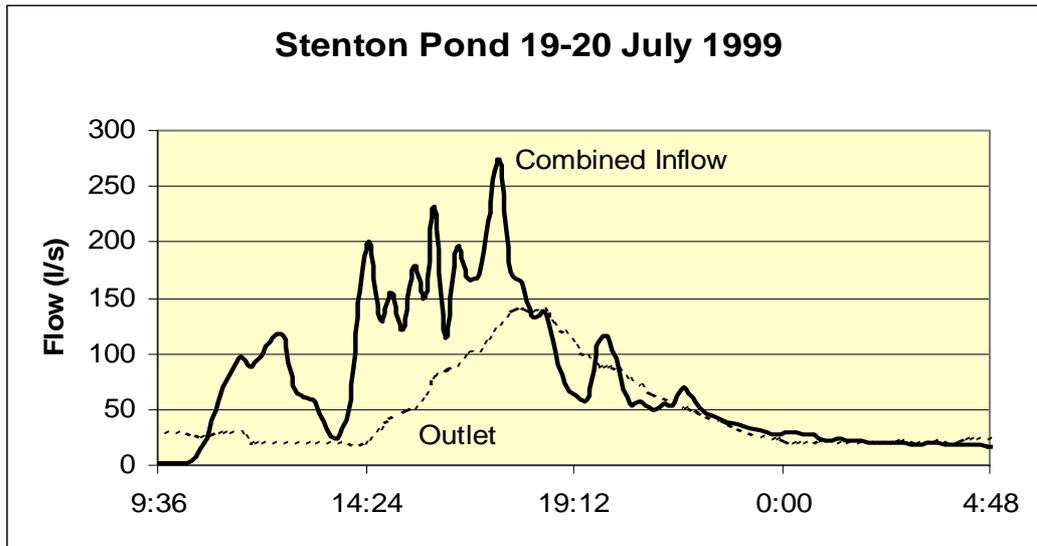
**Figure 5.4 Flows During event of 19-20 July 1999**
