## PART B

### SUDS Performance Data Summary Sheets

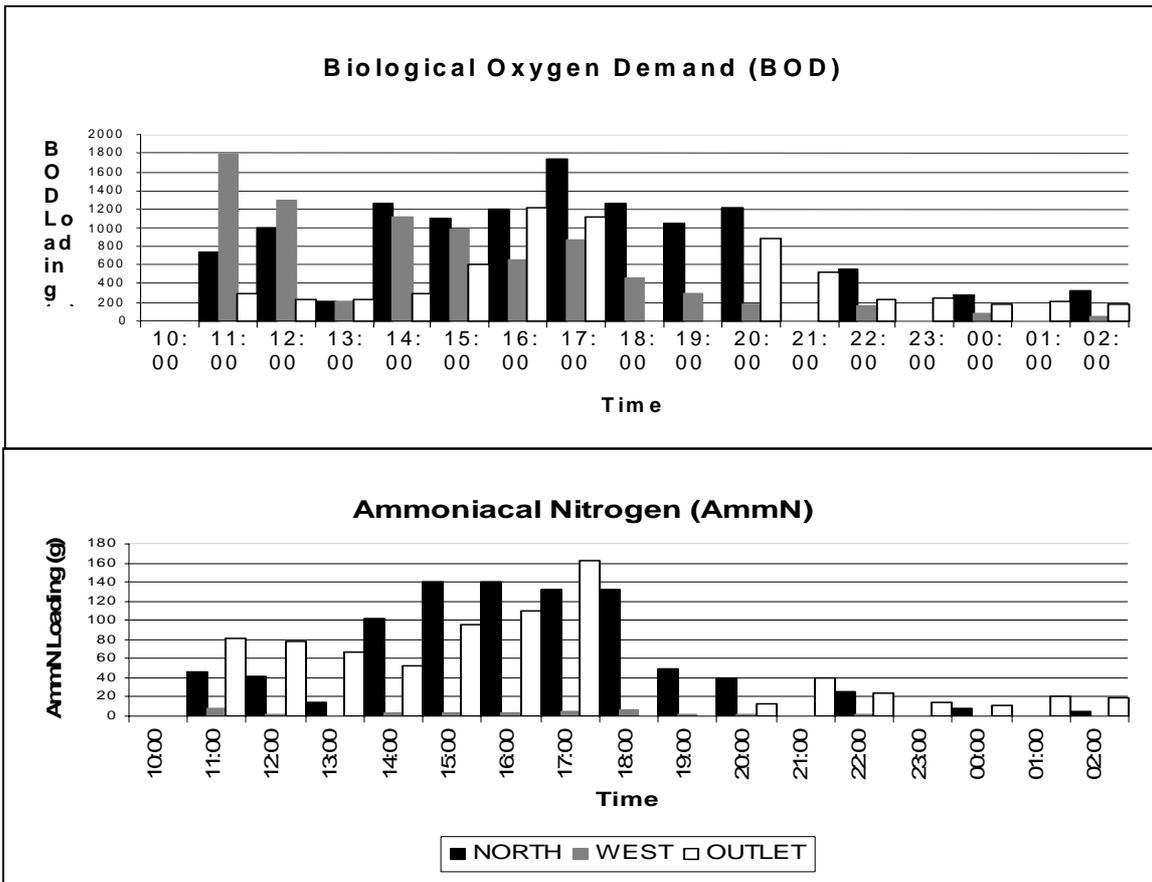
**Figure 5.5 Water Qualities Event of 19 – 20 July 1999**

EMC for Cu remained almost the same at the outlet, however all other metal concentrations were reduced. The metals loads were all significantly reduced.

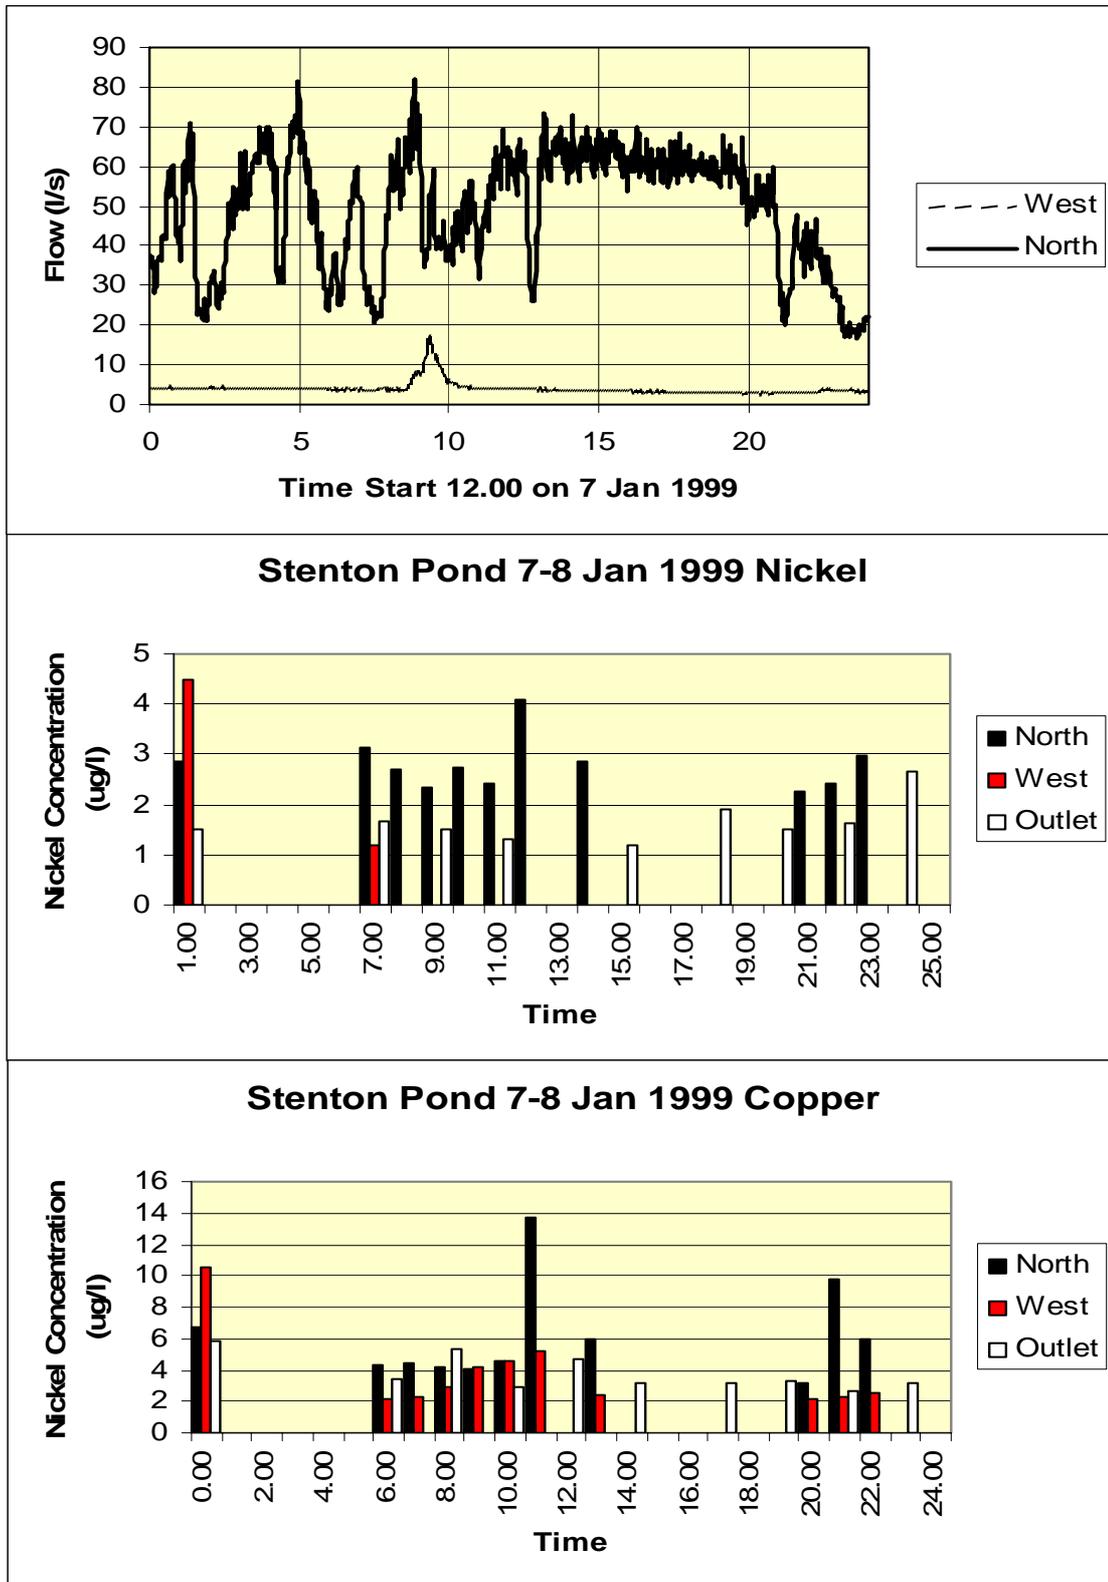
Heavy Metals concentrations were monitored during this event. The inflow hydrographs indicate a problem with the north inflow which was probably due to a malfunctioning combined sewer overflow.

Figure 5.6 Observations During event of 7-8 Jan 1999

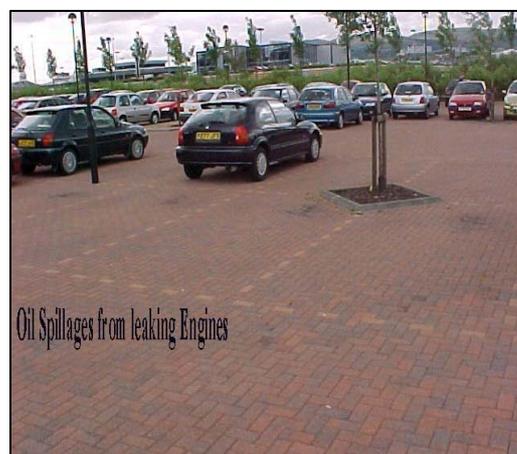
This is a large car park for an office complex. There is a high water table in the area and the whole system was lined to prevent hydraulic contact with groundwater. Flows were monitored for 6 months from 16<sup>th</sup> February to 10<sup>th</sup> August 2000 and outflow quality from 5<sup>th</sup> June until 10<sup>th</sup> August 2000. Flow was monitored during sixteen events and samples were obtained during four events.

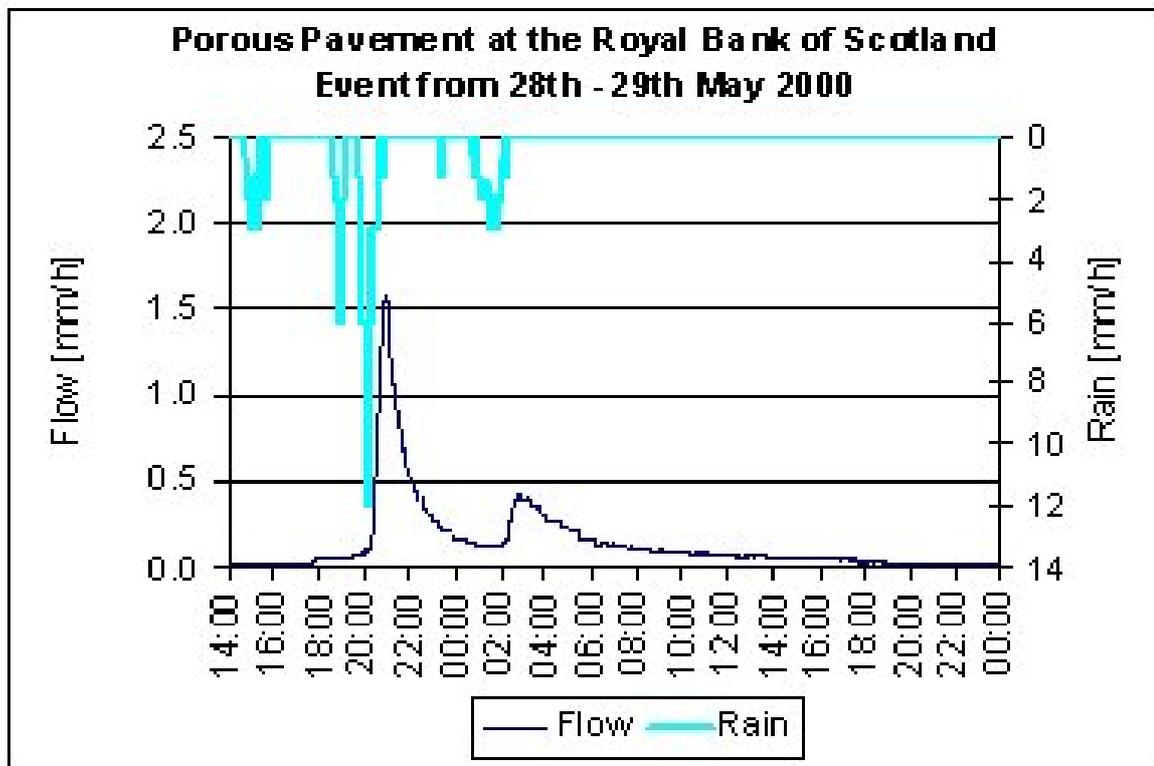
Typical hydrograph from the study site

Key hydrological results are: Average percentage outflow of just under 50%; lag times of 45 minutes for medium and 145 minutes for small events and; initial rainfall capacity in the order of 1.65mm. The antecedent precipitation index API<sub>5</sub> shows that the porous pavement is heavily influenced by antecedent conditions.

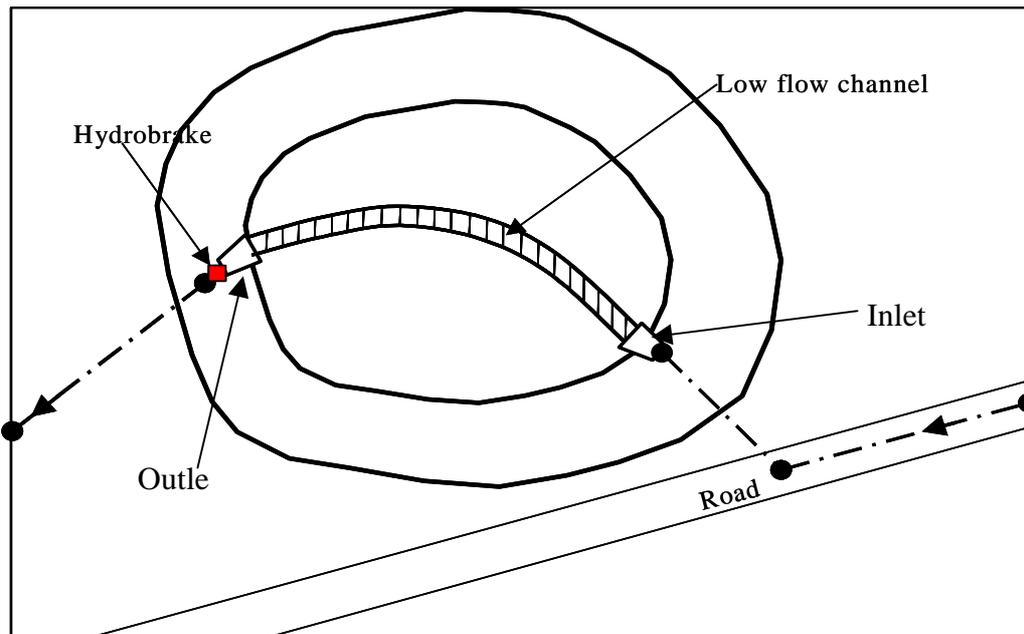
**Figure 8.2 Detention Basin D/M Schematic Layout**

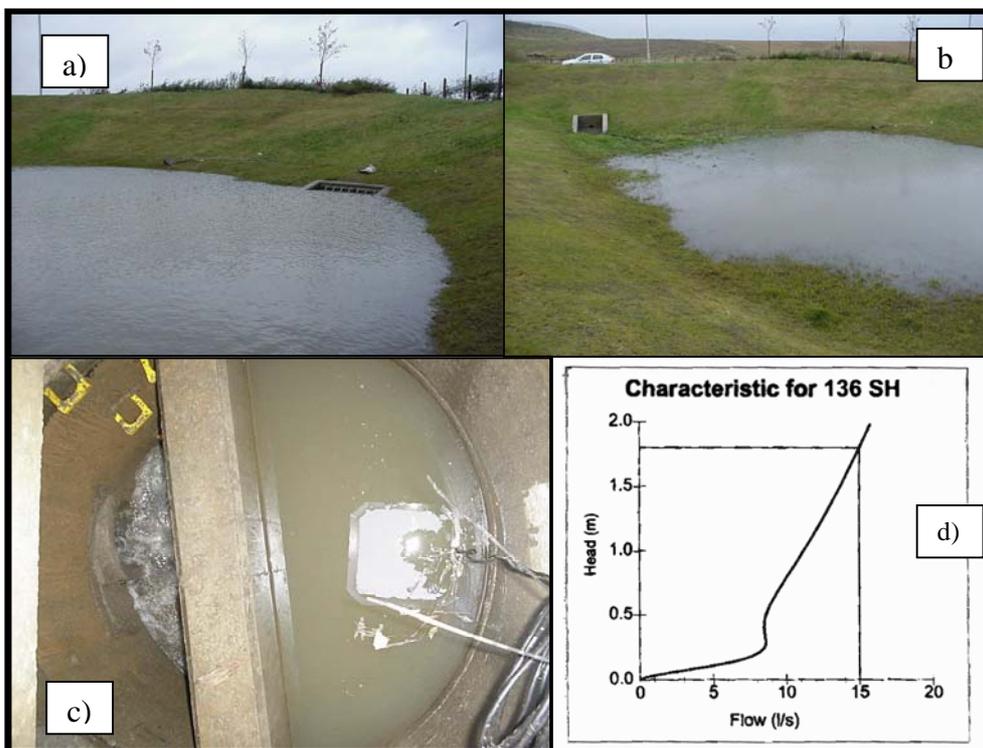
**Figure 8.3 Detention Basin D/M in Operation**

- a) During heavy rainfall on 7 Nov 2000. Outlet nearly submerged
- b) Inlet taken at same time as a).
- c) Outlet manhole during same event. Wall (top to bottom) separates detention basin (Right) from continuation pipe(Left). Hydrobrake is in wall.
- d) Hydrobrake head v flow curve.

The outlet from this detention basin is at the invert level of the basin and flow is controlled by a Hydrobrake located in a manhole immediately downstream from the outlet structure. The Hydrobrake (see Figure 8.3 d)) was specified to pass 15l/s at a head of 1.8m. The outlet manhole (see Figure 8.3 c)) incorporates an overflow weir which permits excess water to flow out of the basin without causing damage.

Hydro-Brake 136 SH in outlet (see flow characteristics on graph in figure 8.3). Maximum flow at outlet = 11.2 l/s (Hydro-Brake was designed on the basis that this flow is reached at one metre water depth).

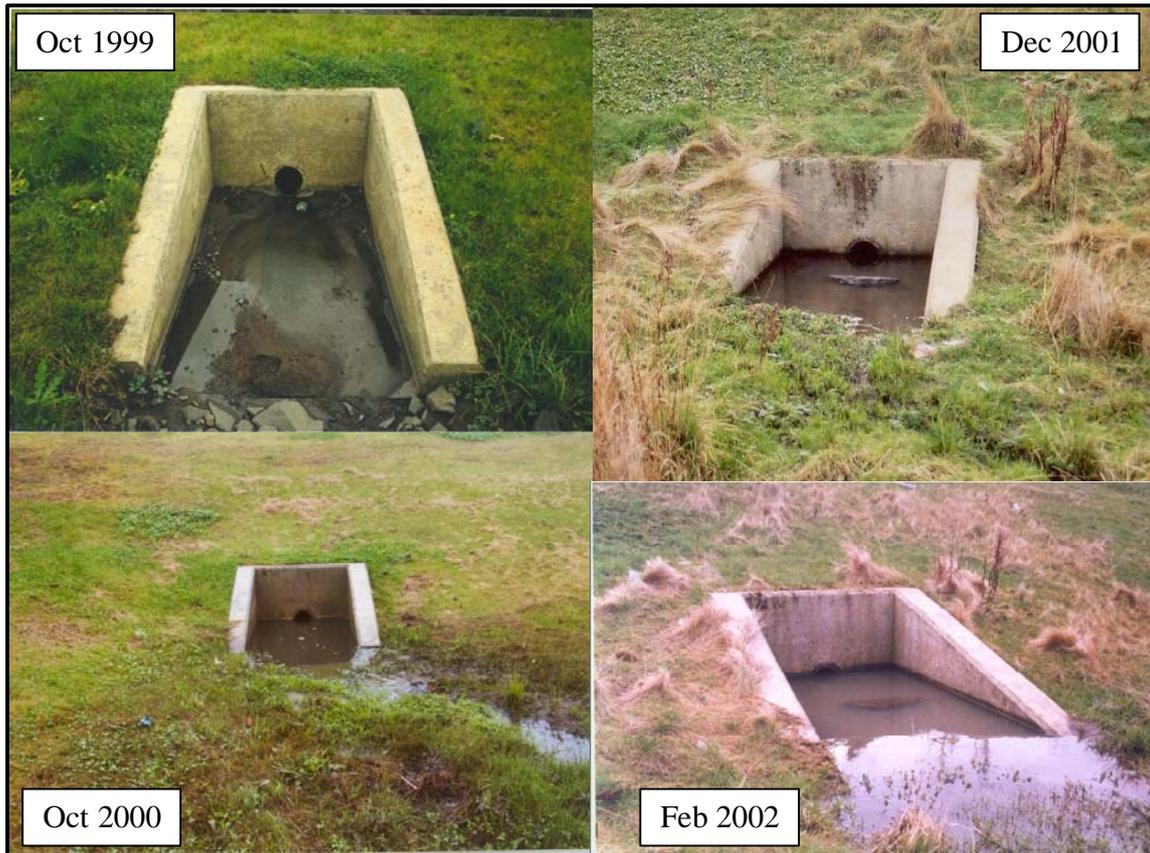
**Figure 8.4 Detention Basin D/M Sedimentation at Inlet**

This series of photographs have been reproduced to show the amount of sediment deposition occurring over a 2 ½ year period. The basin serves only road runoff and construction has terminated by the start of the period of observation. The sediment has caused a general rise in level of the base of the basin by about 300mm and the inlet is now permanently submerged. Operation of the pipe system upstream is not affected since it has steep gradients. Hydraulic performance of the basin is not affected since the reduction in volume is less than 5%. However, the water quality performance will soon be reduced due to fine sediments reaching the outlet because the deposited material has created a gradient across the base, giving the flow an increased velocity during small events.

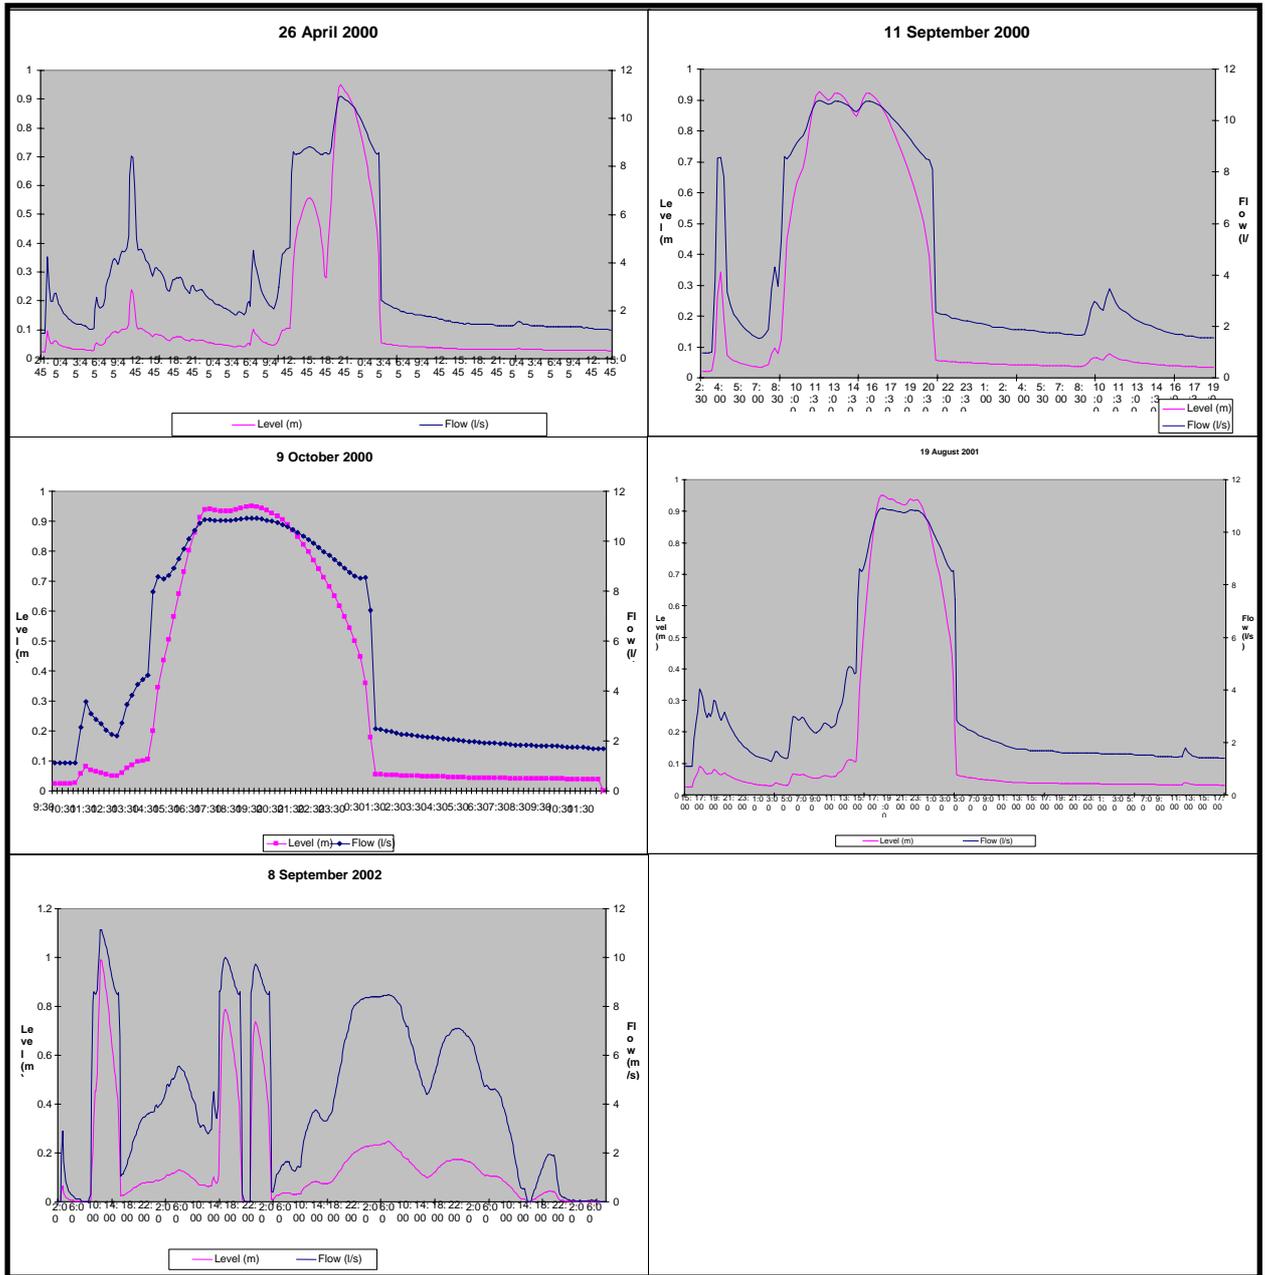
**Figure 8.5 Detention Basin D/M Typical Event Hydrographs**

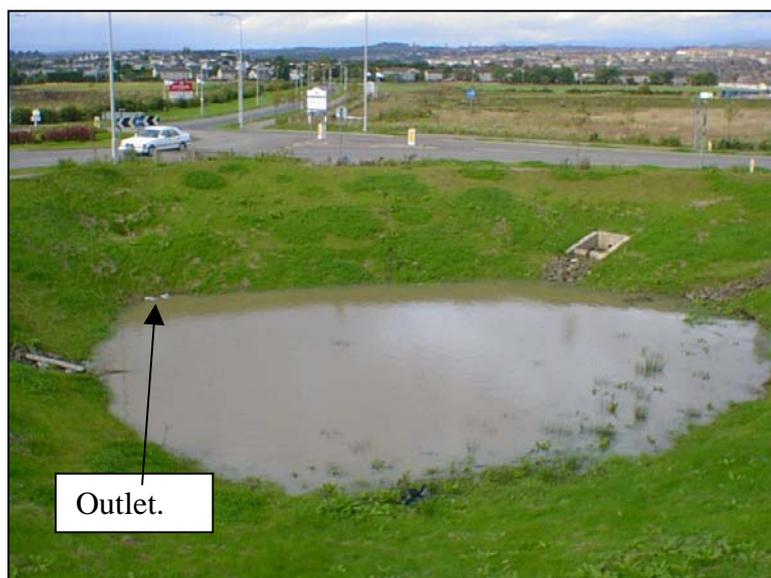
The outlet from this basin was blocked shortly after monitoring commenced. This was due to a large sheet of polythene becoming lodged at a location where access was not possible.

**Figure 9.1 Detention Basin G September 2000**

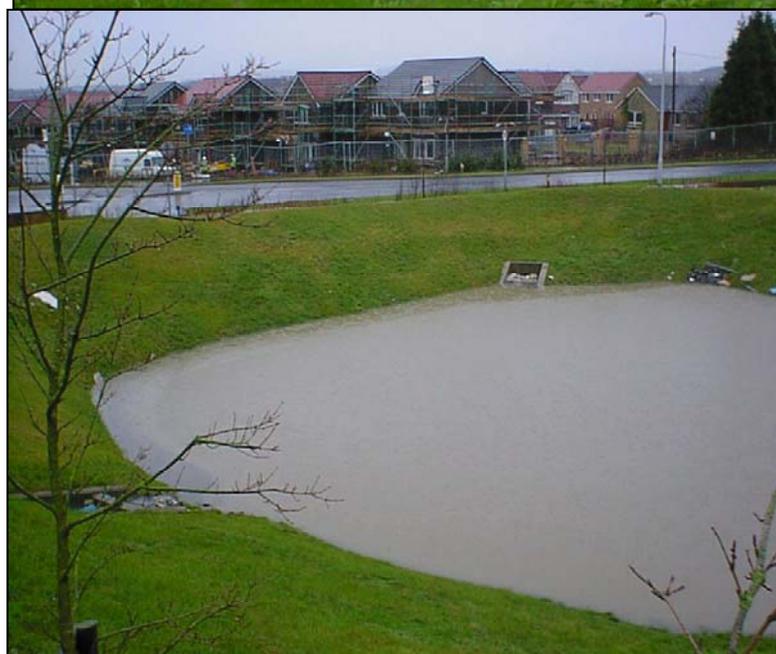
The outlet was blocked during almost the entire period of monitoring and still is. Blockage is caused by a plastic sheet in a downstream pipe. So far all attempts to remove the sheet failed. Water levels can be significantly above one metre over several days during wet periods and during cold periods the water surface in the basin was often frozen. Sediment deposition at both inlets is moderate to large. There is considerable accumulation of sediment in the centre and at the outlet of the basin. Sediment material at inlets is mainly sand and grit. Sediment at outlet is mainly silt and fine sand. Sediment in centre of detention basin is mainly fine sand and silt. Mean sediment depth at inlets = 70 mm, at outlet 40mm (measured on 12 June 2002).

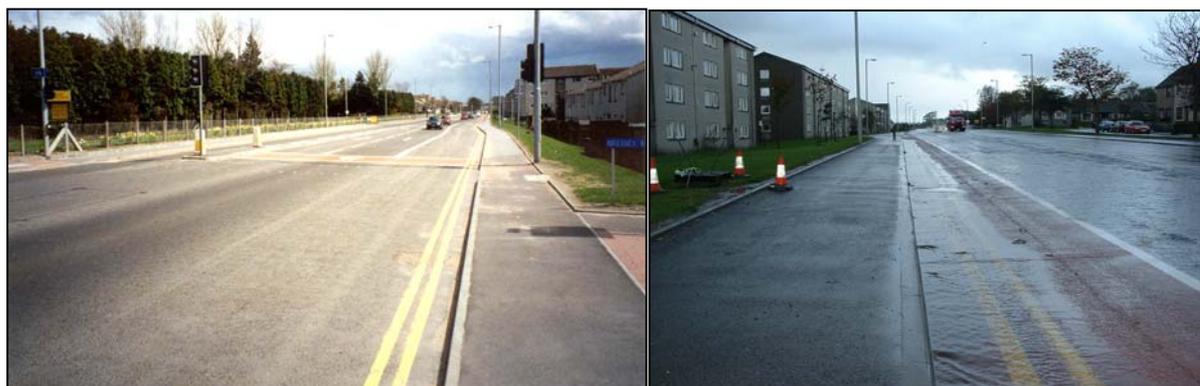
This filter-drain system is located alongside the A944 in Aberdeen where widening and resurfacing was carried out during spring of 1999. The system drains 750 metres of road via 44 trapped gully pots and 11 catch pits and has perforated pipes varying from 150 to 300 mm located in gravel 0.5 m x 1.5 m in cross section. Construction was completed well in advance of monitoring and the contributing area was a busy urban access route, any surfaces being relatively mature. Outflow from the system is to the Denburn sewer. The drainage is designed as an exfiltration system but the area has soil of extremely low permeability. The catchment area is 9,502 m<sup>2</sup>, of tarmac road and footpaths. 124 flow events had been recorded by the end of November 2002 when investigations stopped due to suspected blockage of the inlets. A total of 23 events with water quality data were monitored during two periods.

The overall performance of this system in attenuating low intensity events (<12mm/h) was found to be excellent and maintainability was a key issue. Evidence was gathered concerning the water quality performance which became very poor after 2 ½ years of operation.

The inlet detail used the outlet from a trapped gully pot discharging directly into gravel media. It was found that leaves were able to become retained by the gravel and the inlets became blocked by September 2002. Improved 'maintainable' details are now used in the Aberdeen area where there is also a general presumption against in-ground systems of this nature.

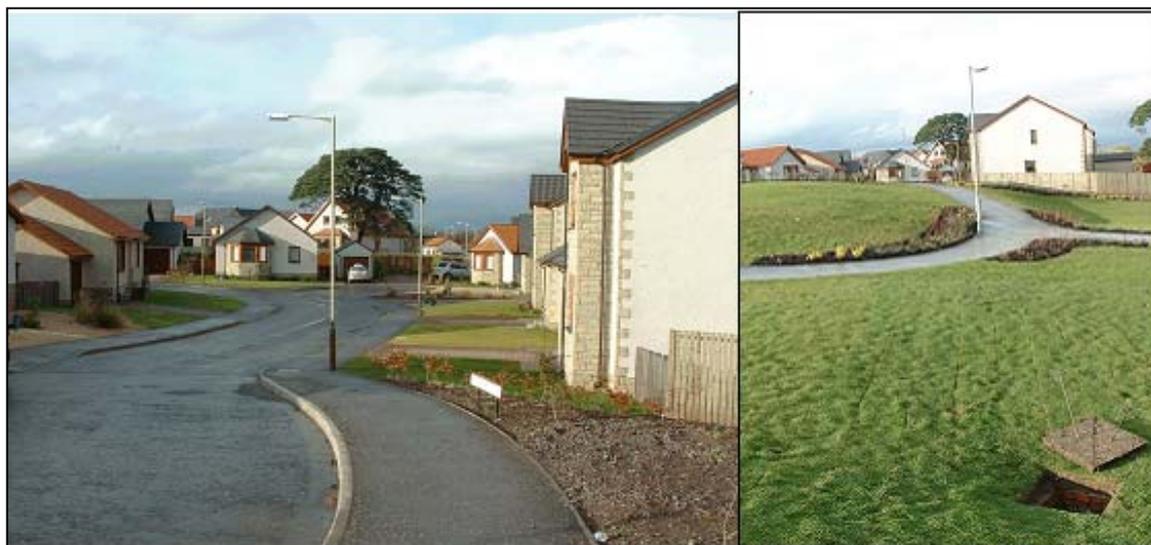
**Photographs of Broxden contributing area and site of filter drain. The open cover is at the outlet manhole.**

This filter drain is on a sloping site in primarily fill material. There is permanent water in the manholes due to the sealed manhole bases. The water table is below base of the system.

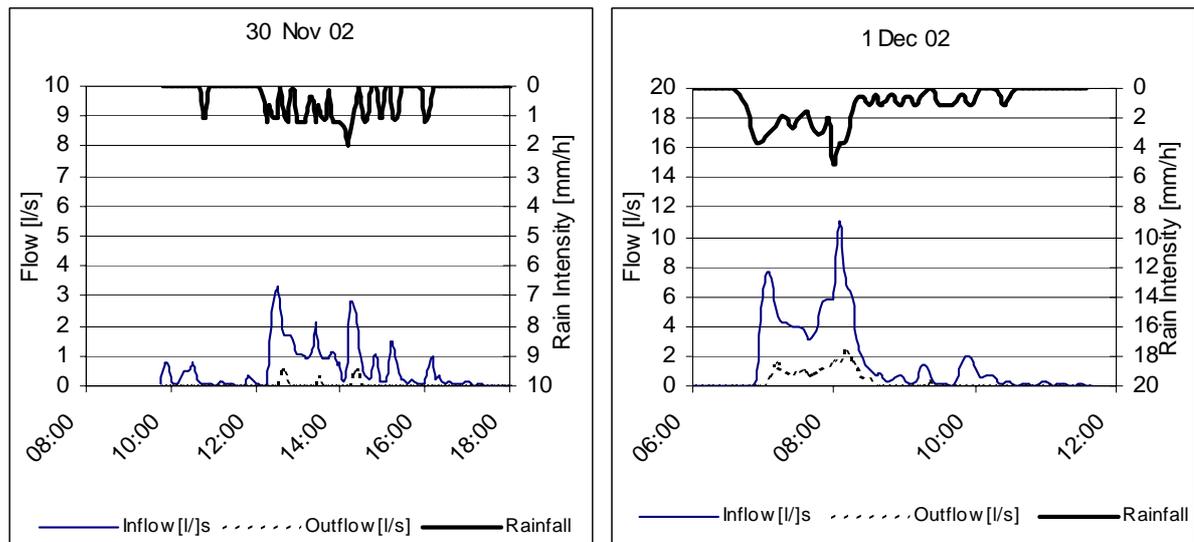
## Inflow and Outflow Hydrographs

The example hydrographs show significant reduction both in peak flowrates and event volumes. The reduction in peak flows averaged 76% while the measured outflow averaged 25% of inflow to the filter drain over 26 events of 2.0mm or greater. There are two possible explanations for this these reductions; exfiltration through the filter media diverted flow away from the outlet pipe (beneficial!) or there was such a degree of attenuation that the outflow was too small for the accuracy of the monitoring equipment (again beneficial). Whichever argument applies, attenuation of flows was very significant.

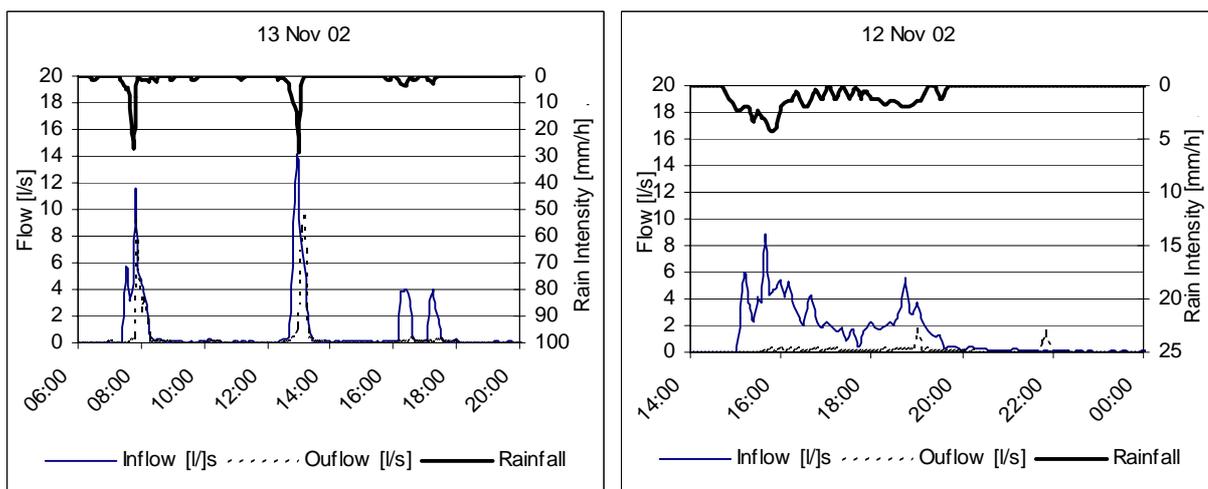
Sample Hydrographs showing rainfall together with inlet and outlet flows

Significant attenuation of peak flows observed as illustrated in the sample hydrographs. Measured outflow from filter drain averaged 14% of inflow over 38 events greater than 2.0mm rainfall (Max 48%; min 3%). In spite of partial blockage of inlet, there was no evidence that hydraulic performance was affected.

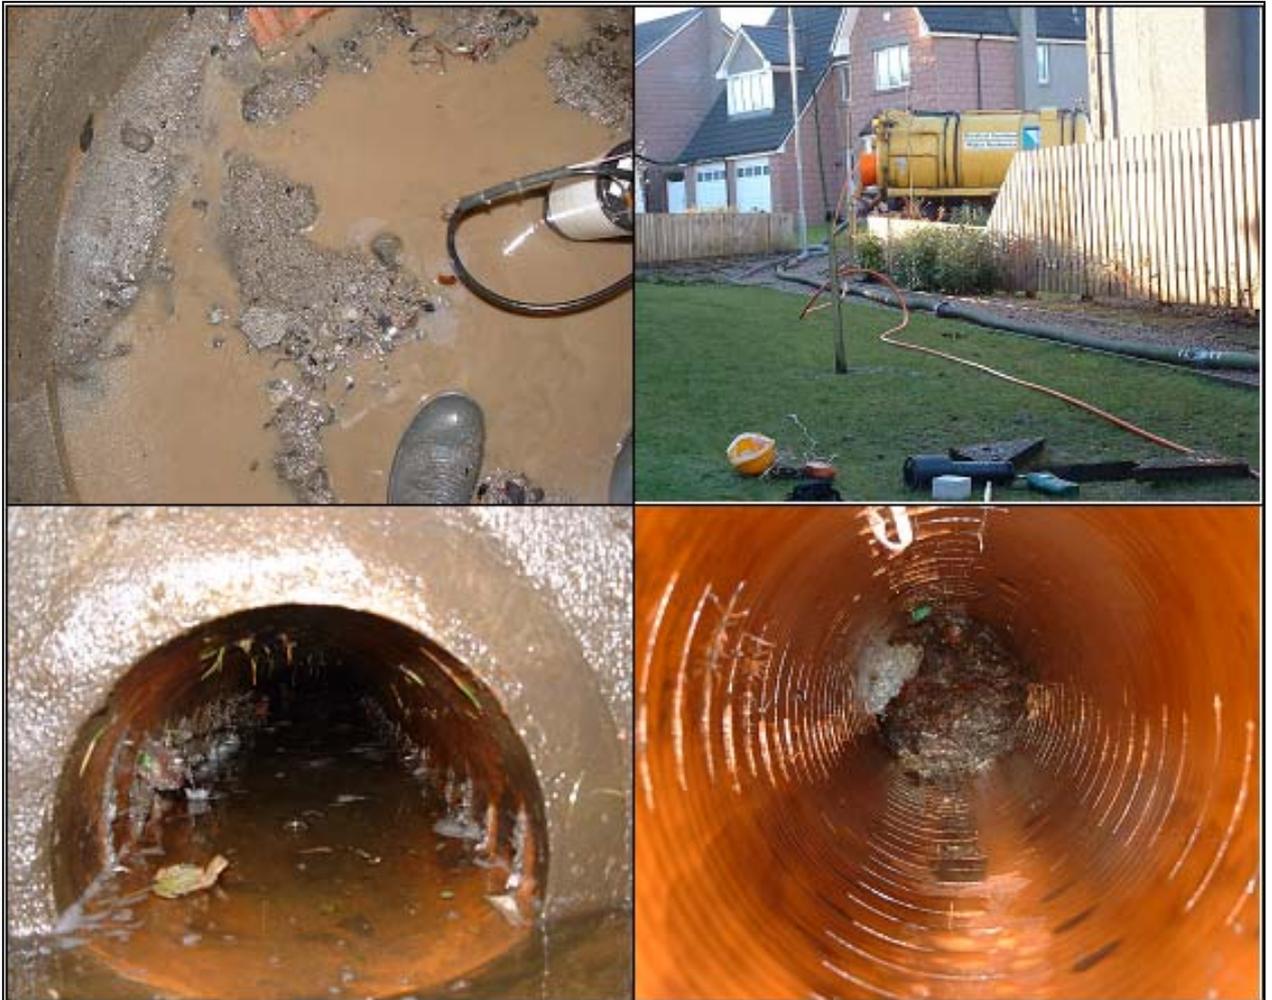
**Walker Dam Photographs - Clockwise from Top Left:** Inlet sump with 400mm depth of gravel; Accessibility for jetting equipment; Inlet to perforated pipe prior to jetting; Inlet to perforated pipe after jetting.

Note: In more recent details, the 'dead' ends of both inlet and outlet pipes have caps which can be removed during cleaning operations.

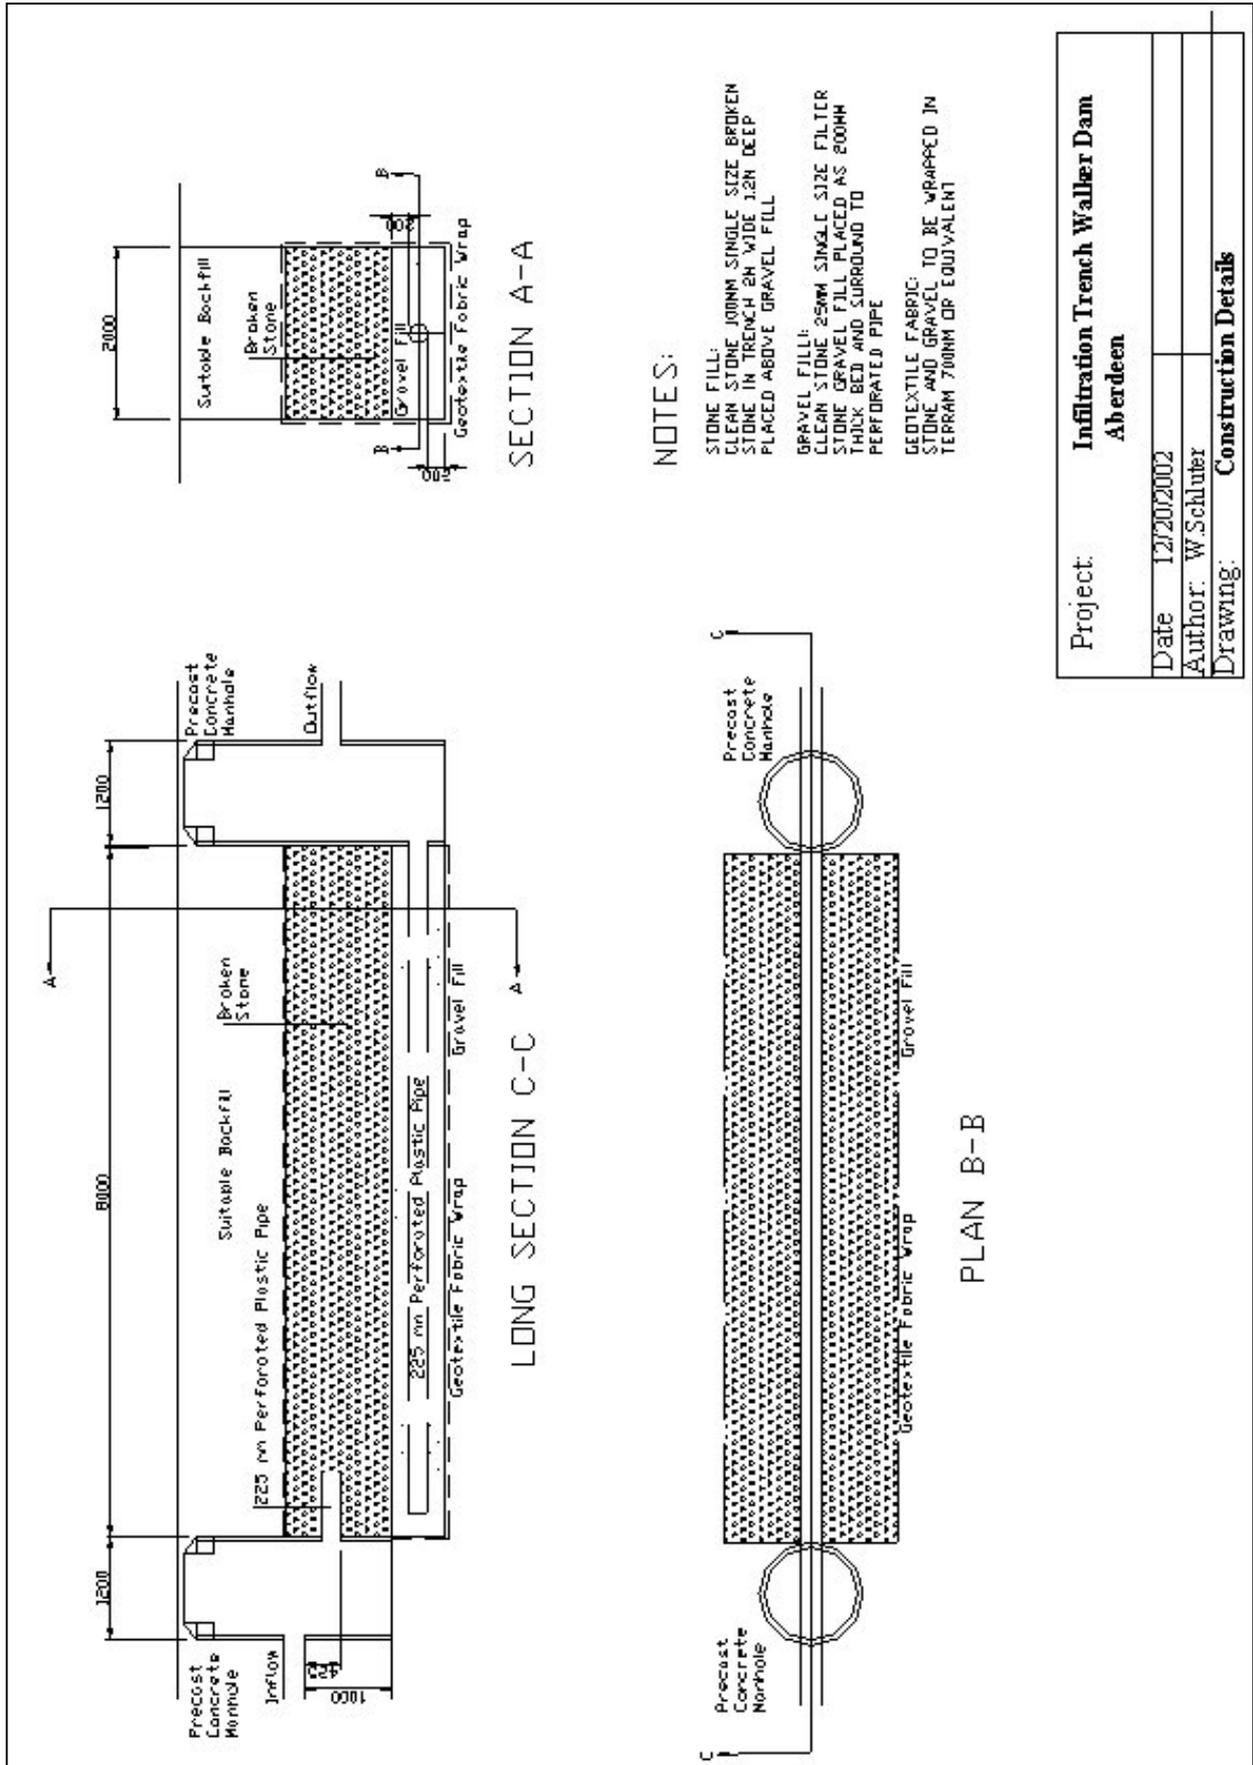
SECTION A-A

- STONE FILL:  
CLEAN STONE 100MM SINGLE SIZE BROKEN STONE IN TRENCH 2M WIDE 1.2M DEEP PLACED ABOVE GRAVEL FILL
- GRAVEL FILL:  
CLEAN STONE 25MM SINGLE SIZE FILTER STONE GRAVEL FILL PLACED AS 200MM THICK BED AND SURROUND TO PERFORATED PIPE
- GEOTEXTILE FABRIC:  
STONE AND GRAVEL TO BE WRAPPED IN TERRAM 700NM OR EQUIVALENT

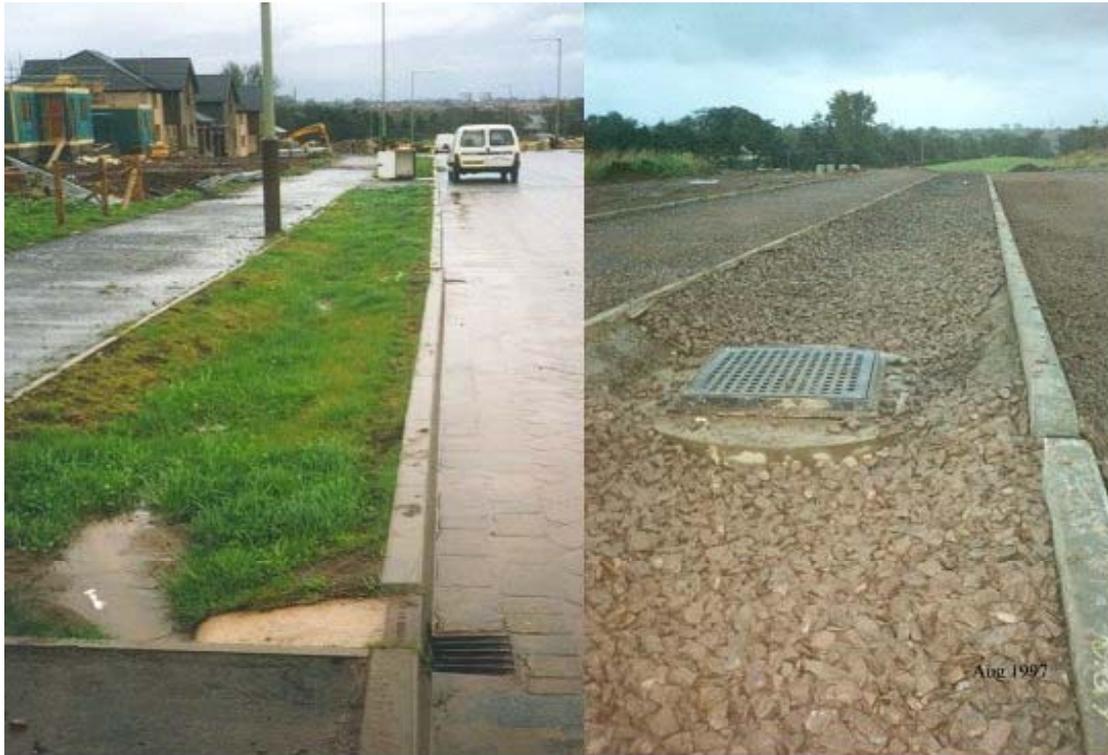
The facility was constructed with a 300mm layer of gravel under the 50mm layer of top soil. The surface was not properly finished and natural vegetation (weeds) were allowed to establish. No maintenance was carried out during the monitoring period, but the performance did not appear to be affected by this lack of maintenance.

**Emmock Woods Swale – Note gravel under layer before topsoiling**

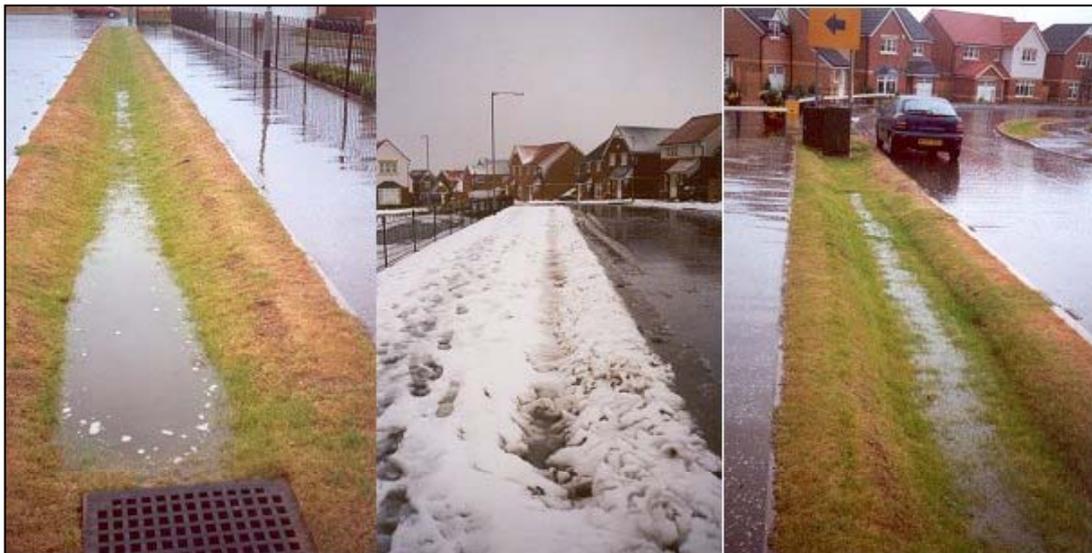
### Swales at West Grange

This roadside detention is very similar in concept to Emmock Woods facility, the chief difference being the absence of the gravel layer directly below the growing medium. The approximate longitudinal slope is 5% and the length monitored was 15.4m.
